# REPORT

## District of Chetwynd Flood Hazard Study

File: 1320.0094.02

November 26, 2018

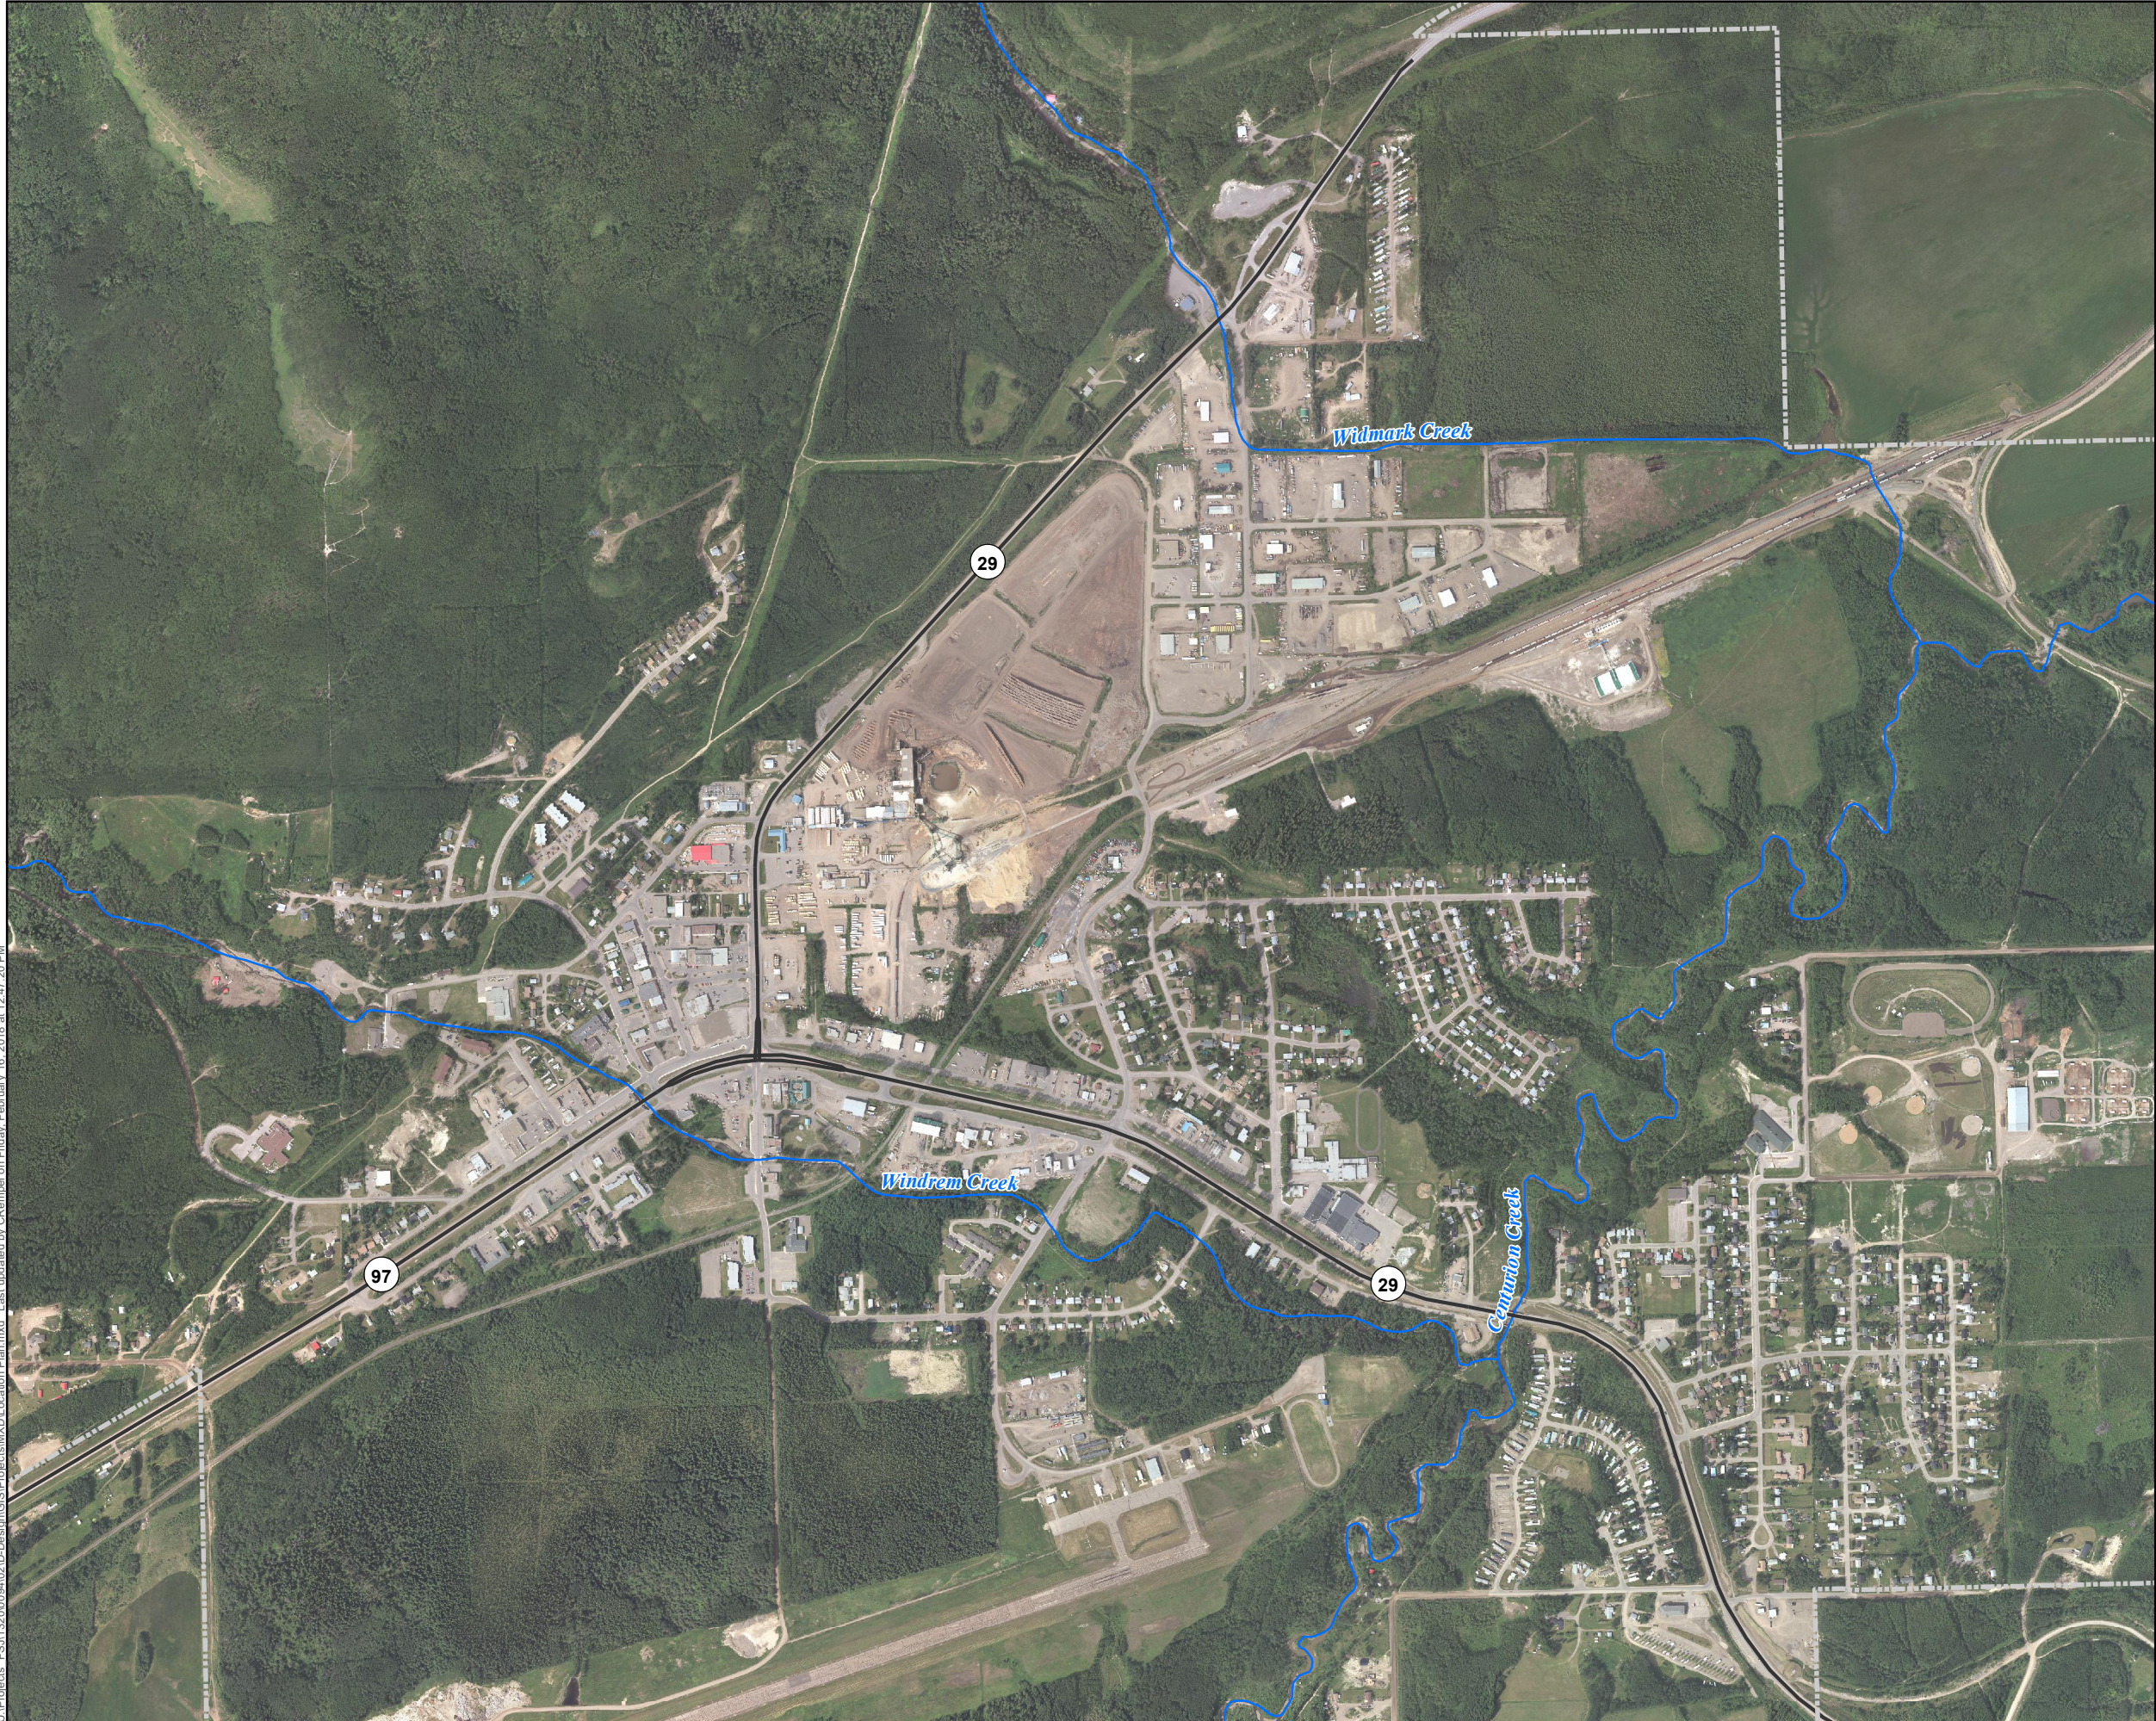
FIGURE 1

The District of Chetwynd is located at the junction of Highways 97 and 29, in the foothills on the eastern slope of the Rocky Mountains. Chetwynd is in the Pine River watershed, and is characterized by three creeks that flow through the community. These include Centurion, Windrem, and Widmark Creeks. These features are shown in Figure 1.

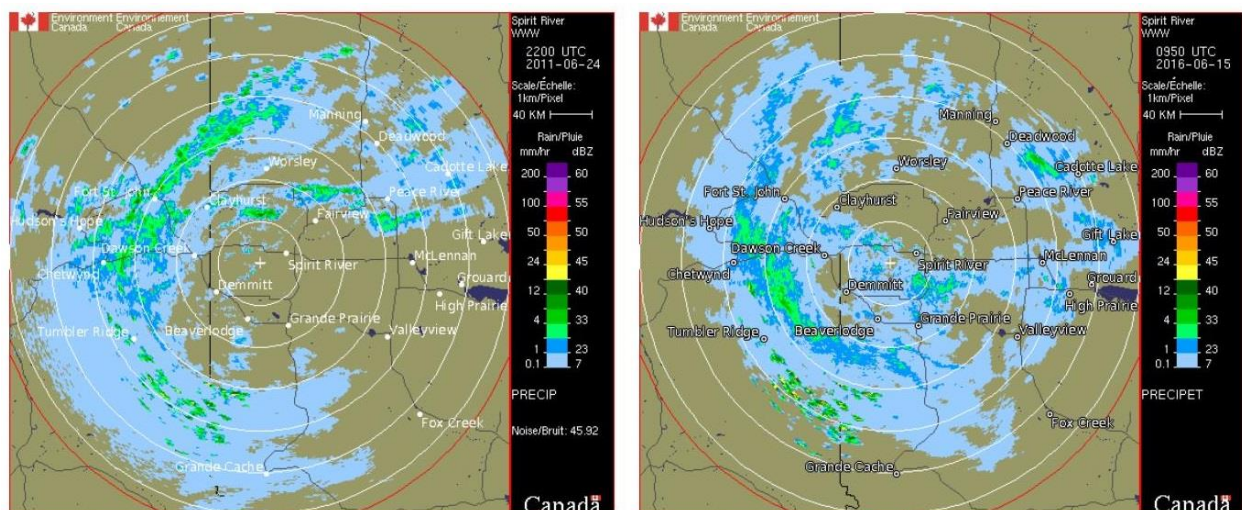
**Figure 2 – Historic Rainfall Event Radar Images From 2011 & 2016**

Another foundational concept is aerial extent, or the area covered by the storm event. Some rainfall events cover relatively small areas, often only a few square kilometers at most. Mid-summer thundershowers are example of events that cover relatively small areas. Others cover very large areas, sometimes thousands of square kilometers at the same time. Figure 2 shows the radar images of the rainfall intensity for the 2011 rainfall event on the left and the 2016 event on the right. In both cases the rain was generated by weather systems covering very broad areas, several hundreds of square kilometers in size. Rainfall from events of this type tend to have a greater impact on creeks like those in Chetwynd.

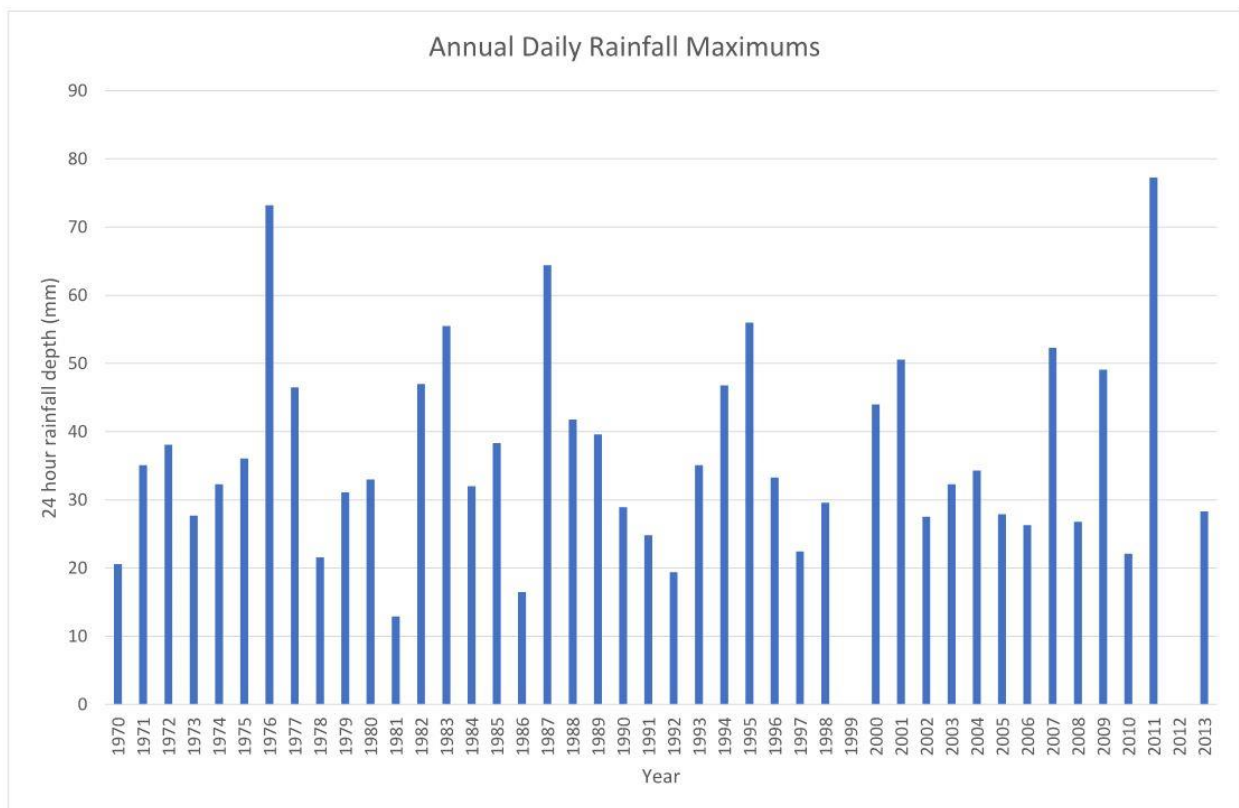
**Figure 3 – Annual Daily Rainfall Maximums**

Historical rainfall data forms the basis of hydrologic analysis. It is generated from weather recording stations located throughout the country and is available from Meteorological Services Canada (MSC), which is a department of Environment Canada. One of these stations is located in Chetwynd at the airport, and is referenced as Chetwynd A, station number 1181508. This station has been used to gather daily rainfall data since 1970, but data is available from MSC only up to 2013. Figure 3 provides a graphic representation of the measured maximum rainfall depths over a 24-hour period for each year in the period of record.

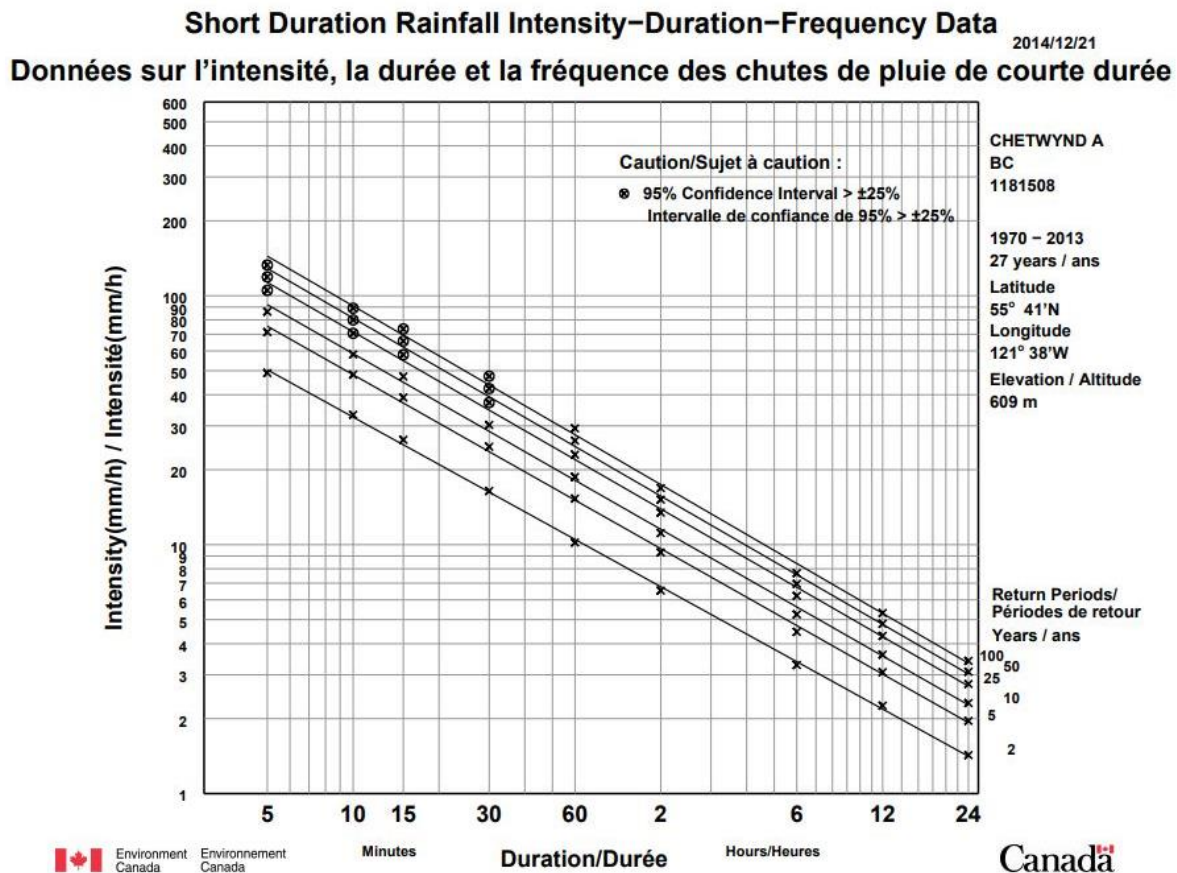
Figure 4 – Chetwynd A IDF Curve

MSC has undertaken a statistical analysis on this data set to create estimated values for a range of return periods from 2 years to 100 years. This information is summarized in an intensity-duration-frequency (IDF) curve for each station. The IDF curve for Chetwynd A is shown on Figure 4.

Using this data set and IDF curve, estimated values can be calculated for rainfall events of various durations and return periods. Table 1 provides estimated maximum rainfall values for 24 hour periods for a standard range of return periods from 2 year (relatively common) to 100 year (relatively infrequent).

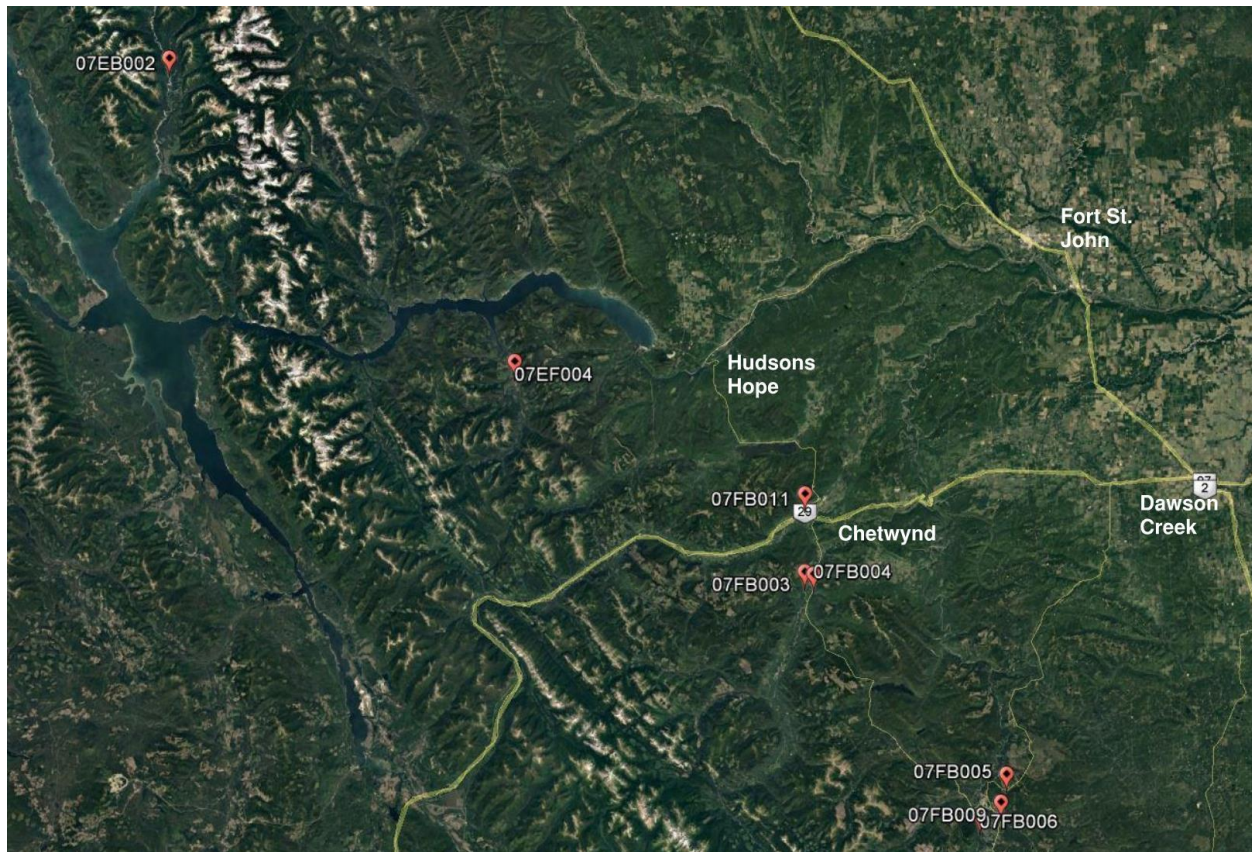
**Figure 5 – WSC Flow Recording Stations for Regional Analysis**

For this case, a total of 8 flow recording stations were used. For each station, statistical analysis was performed on the station data set to estimate 100 year and 200 year return period peak flow estimates using the Log Pearson Type III distribution function. The station locations and WSC identifier are shown in Figure 5 on the following page.

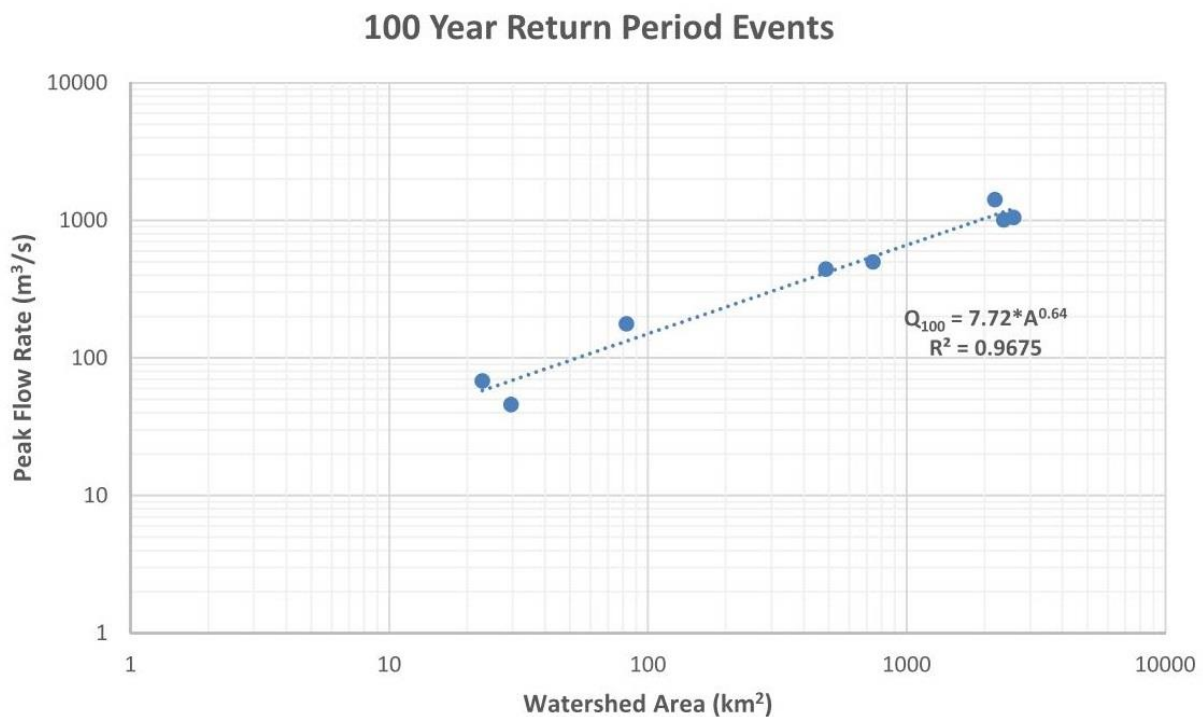
**Figure 6 – Regression Equation for 100 Year Return Period Events**

Table 5, on the following page, provides a summary of the estimated 100 year and 200 year return period flow rates for both the statistical analysis and the resulting regional regression equation. The regression curves are provided on Figure 6 for the 100 year event and Figure 7 for the 200 year event.

The regional analysis results in somewhat lower values for the estimates of the 100 and 200 year return period events for the Windrem Creek watershed when compared to the results based only on that data for that station. The resulting values are 59 m<sup>3</sup>/s for the 100 year event, and 102 m<sup>3</sup>/s for the 200 year event.

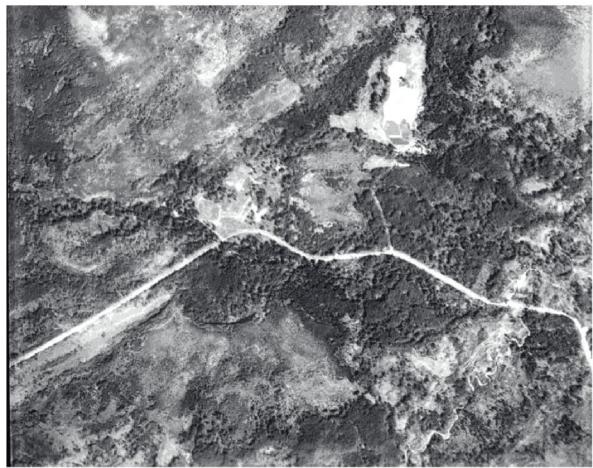
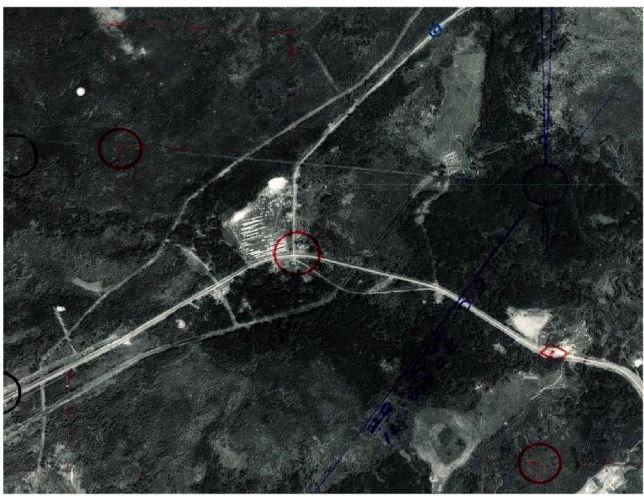
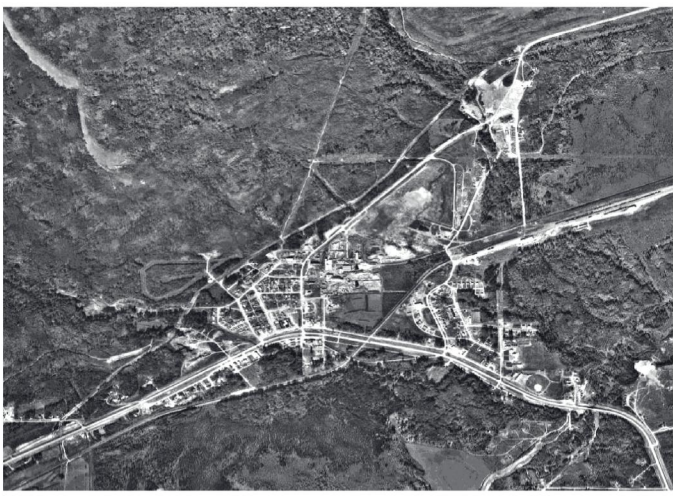
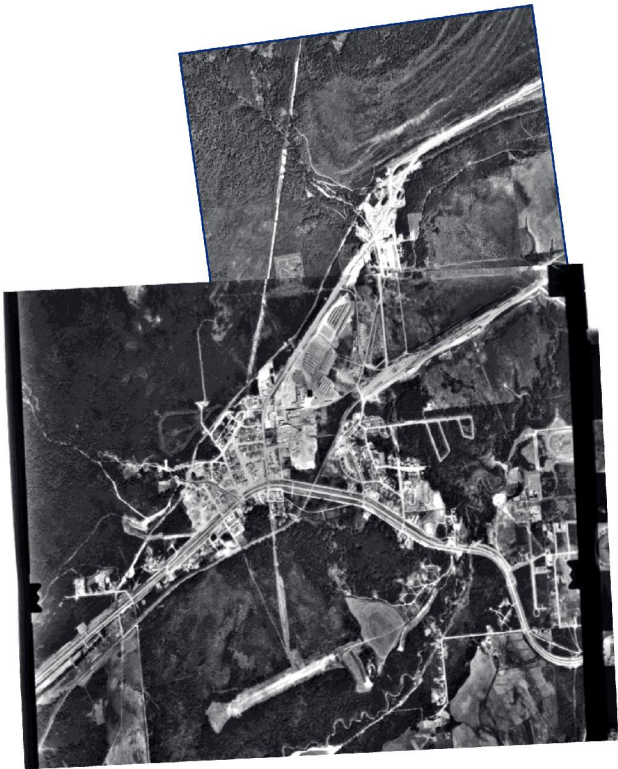
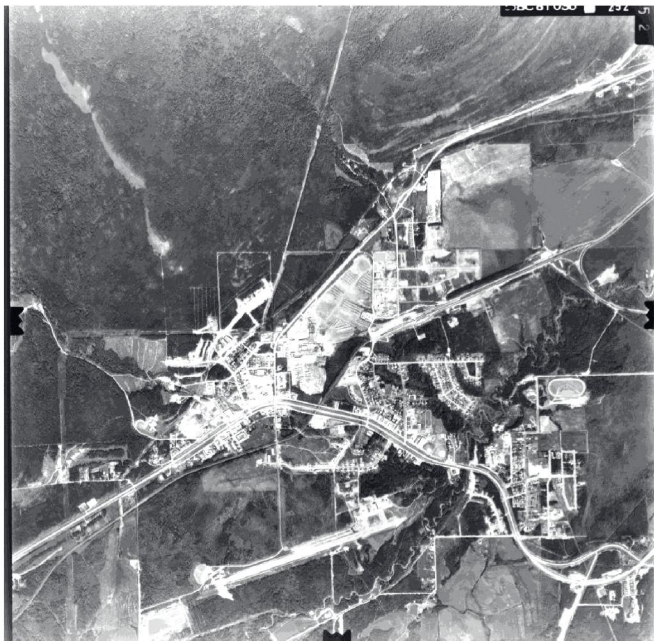
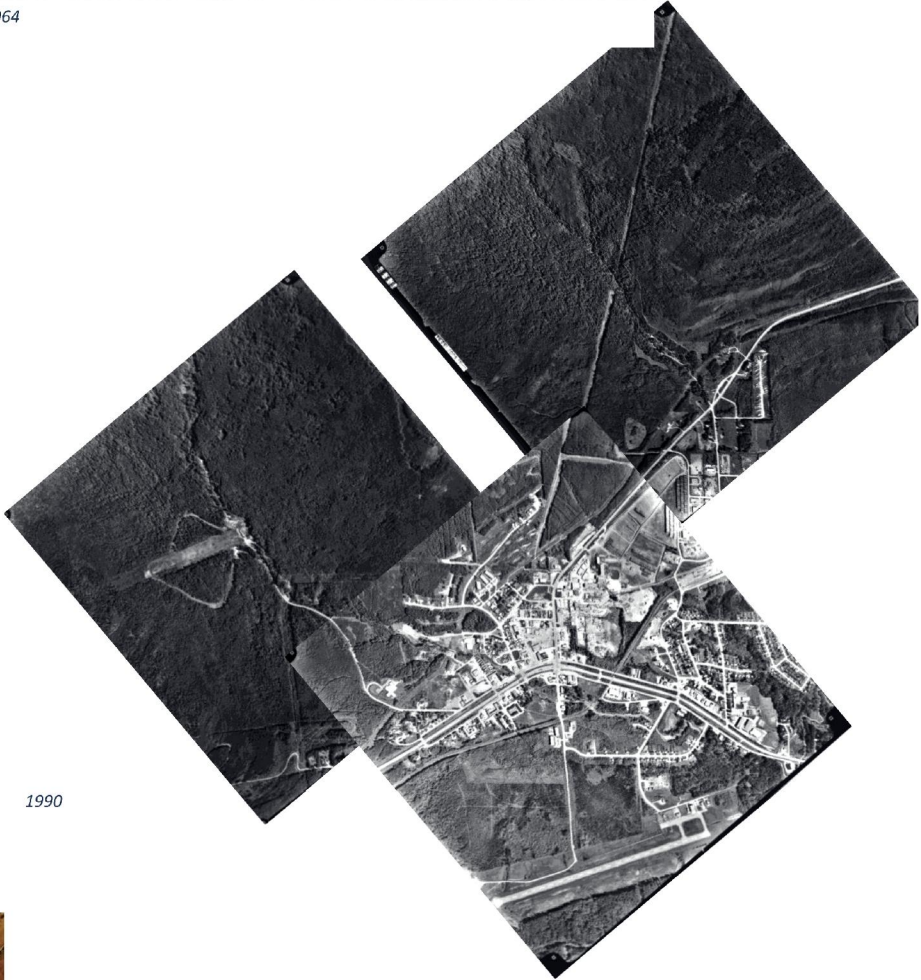
FIGURE 8

The assessment of watershed conditions began with a review of historic air photos, which were available for the years of 1945, 1956, 1964, 1969, 1981, 1990, 1997, 2006, and 2016. The air photos are shown on Figure 8, and clearly show the growth and development of Chetwynd since its founding. More importantly, the air photos show that the creek channels are relatively stable over this time period, and have not moved due to flood events. It should be noted, however, that Widmark Creek was intentionally realigned at some point between 1956 and 1964 in conjunction with land development.

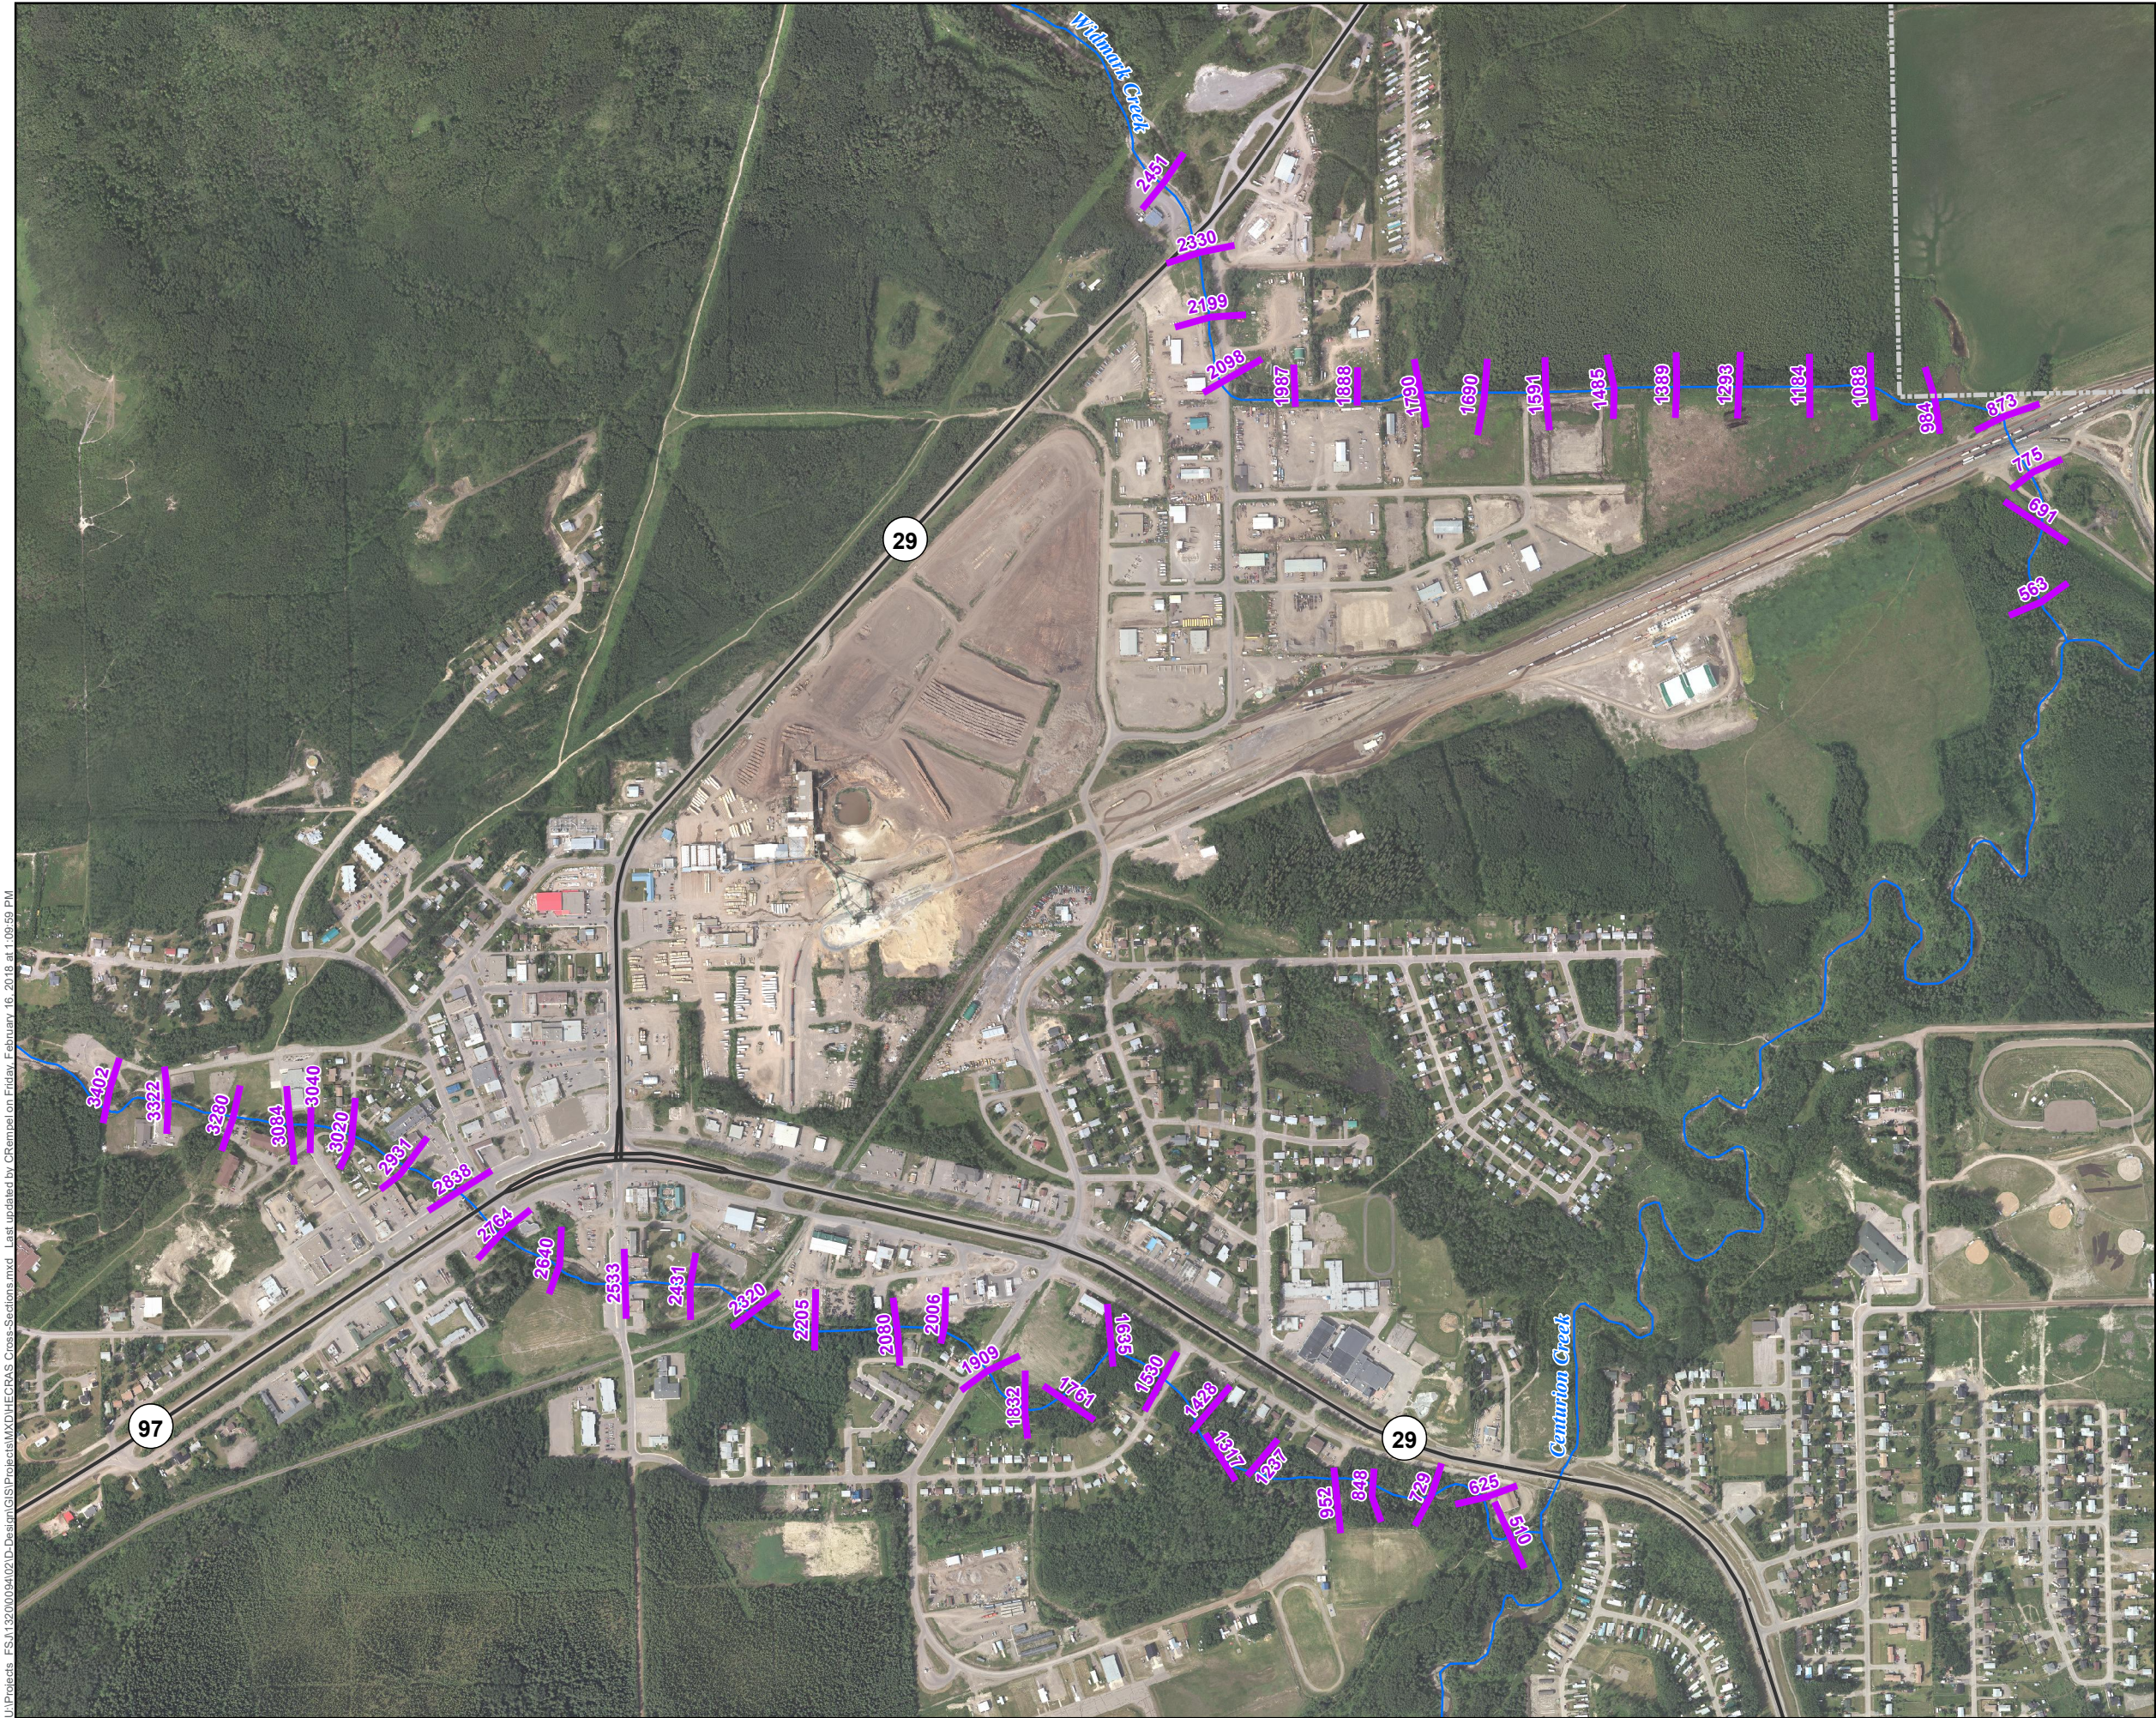
FIGURE 9

One of the more striking characteristics about the watersheds is revealed by the contour map shown on Figure 9. The contours show the characteristics of alluvial fans for both watersheds. This means that both watersheds have been and continue to be significant sources of gravel and other eroded material, and Chetwynd is located at the mouth of the canyons, which is the primary location where the material is deposited.

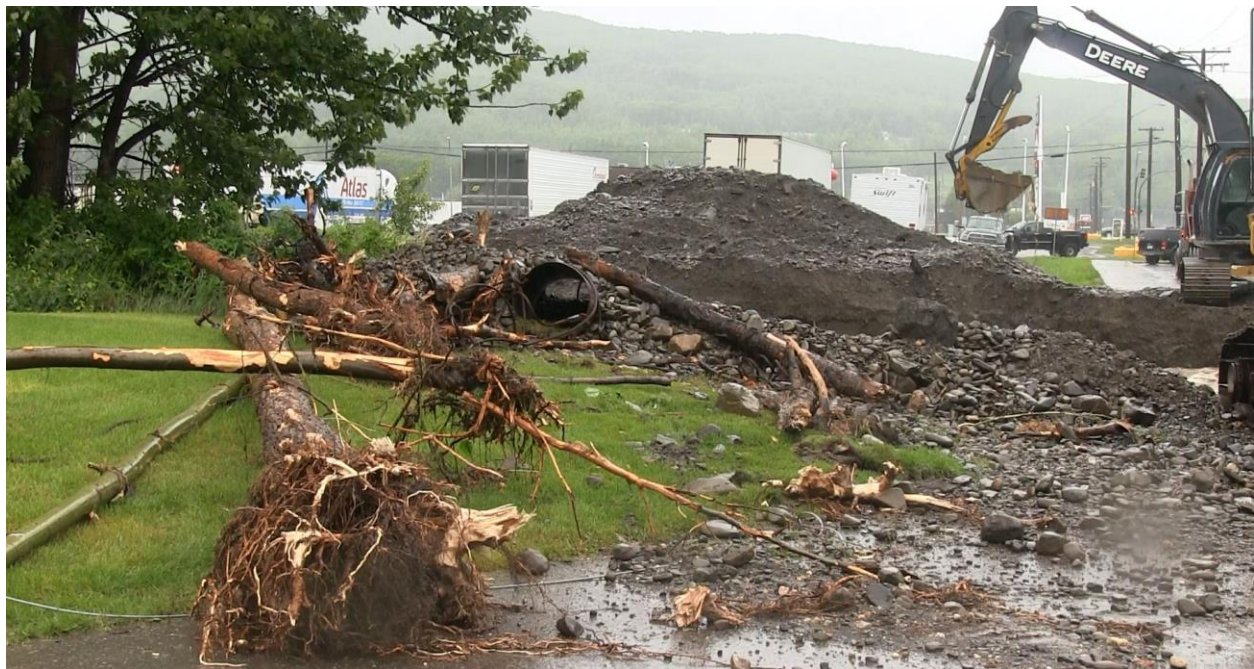
**Figure 11 – Woody Debris and Gravel**

The most significant observation is that both Windrem Creek and Widmark Creek mobilize significant quantities of woody debris and gravel during flood events. Figure 11 shows gravel, rocks, boulders and woody debris being removed from the channel immediately upstream of the 50<sup>th</sup> Street bridge crossing during the 2016 flood event.

The mobilized material has two significant adverse impacts. One impact is that the gravel and boulders temporarily accumulate in the channel at various locations as it moves downstream, which reduces the capacity of the main channel, and increases the likelihood that the creeks will overtop their banks and flood adjacent properties. The second impact is that both the gravel and the debris have the potential to partially or completely block cross structures, such as bridges and culverts.

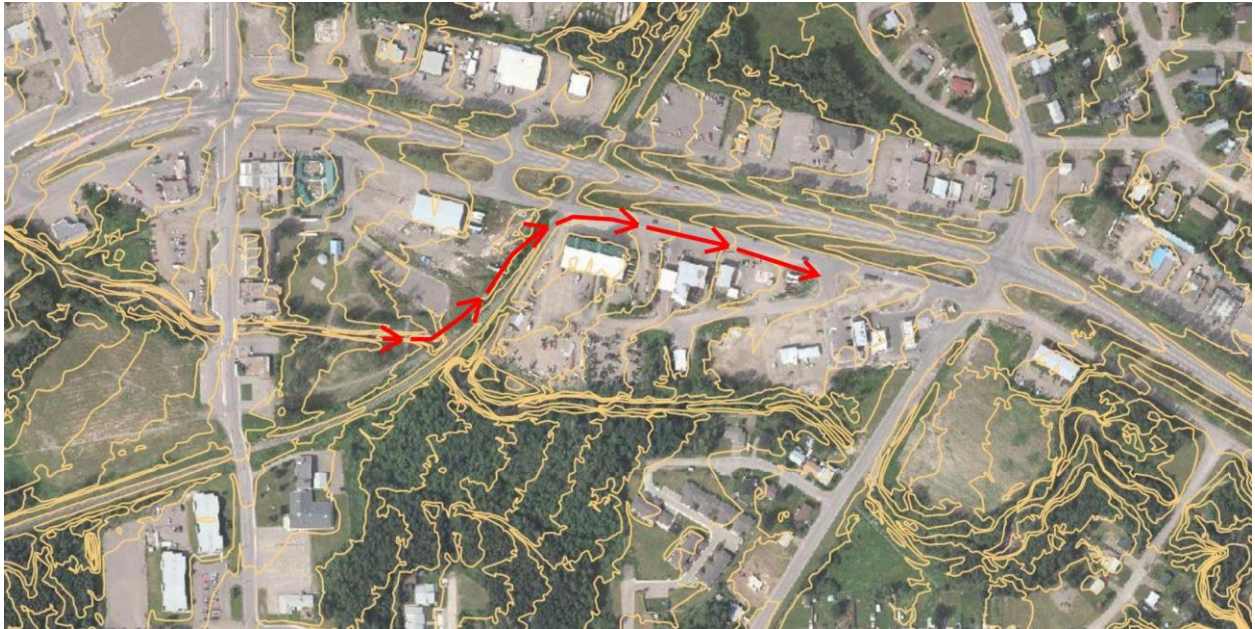
**Figure 12 – Flow Path Following Blockage of CN Rail Culverts**

It is known that during the 2016 flood event gravel and debris blocked the CN Rail crossing, which caused flood waters to flow onto the South Access Road along the route shown in Figure 12. Similarly, debris blocked Widmark Creek at the Highway 22 culvert, causing flood waters to overtop the highway and flow onto adjacent properties as shown on Figure 13. The blockage at the CN Rail was so severe during the 2016 flood event that a decision was taken by the District of Chetwynd emergency responders to breach the railway and relieve the flooding and overflow.

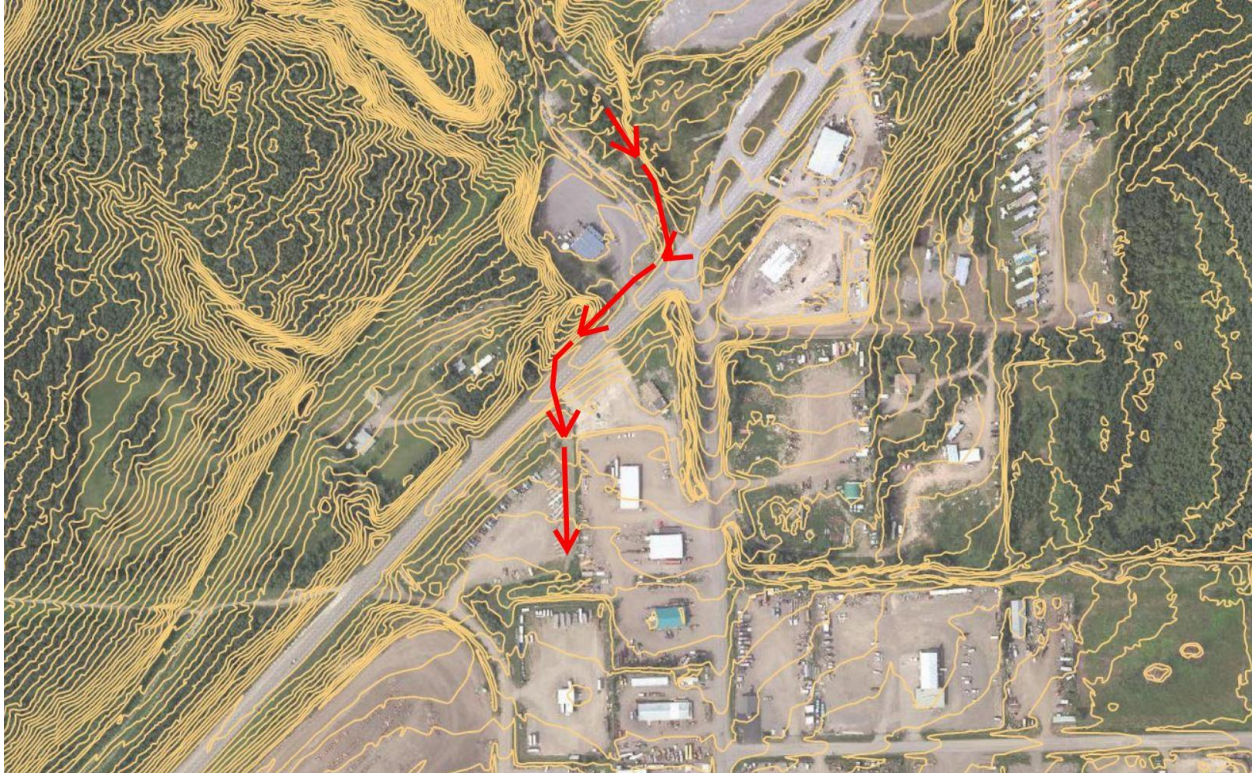
**Figure 13 – Flow Path Following Blockage of Highway 22 Culverts**

- Highway 29 culvert – the culvert is undersized for the estimated peak extreme event flows. Even without the risk of blockage by floating debris, this culvert will be overwhelmed during the extreme flows, and will cause flood waters to flow to the southwest, and overtop Highway 29 approximately 100 m from the crossing location. This will cause uncontrolled flooding of properties immediately south of Highway 29 as is known to have occurred during the 2016 flood.

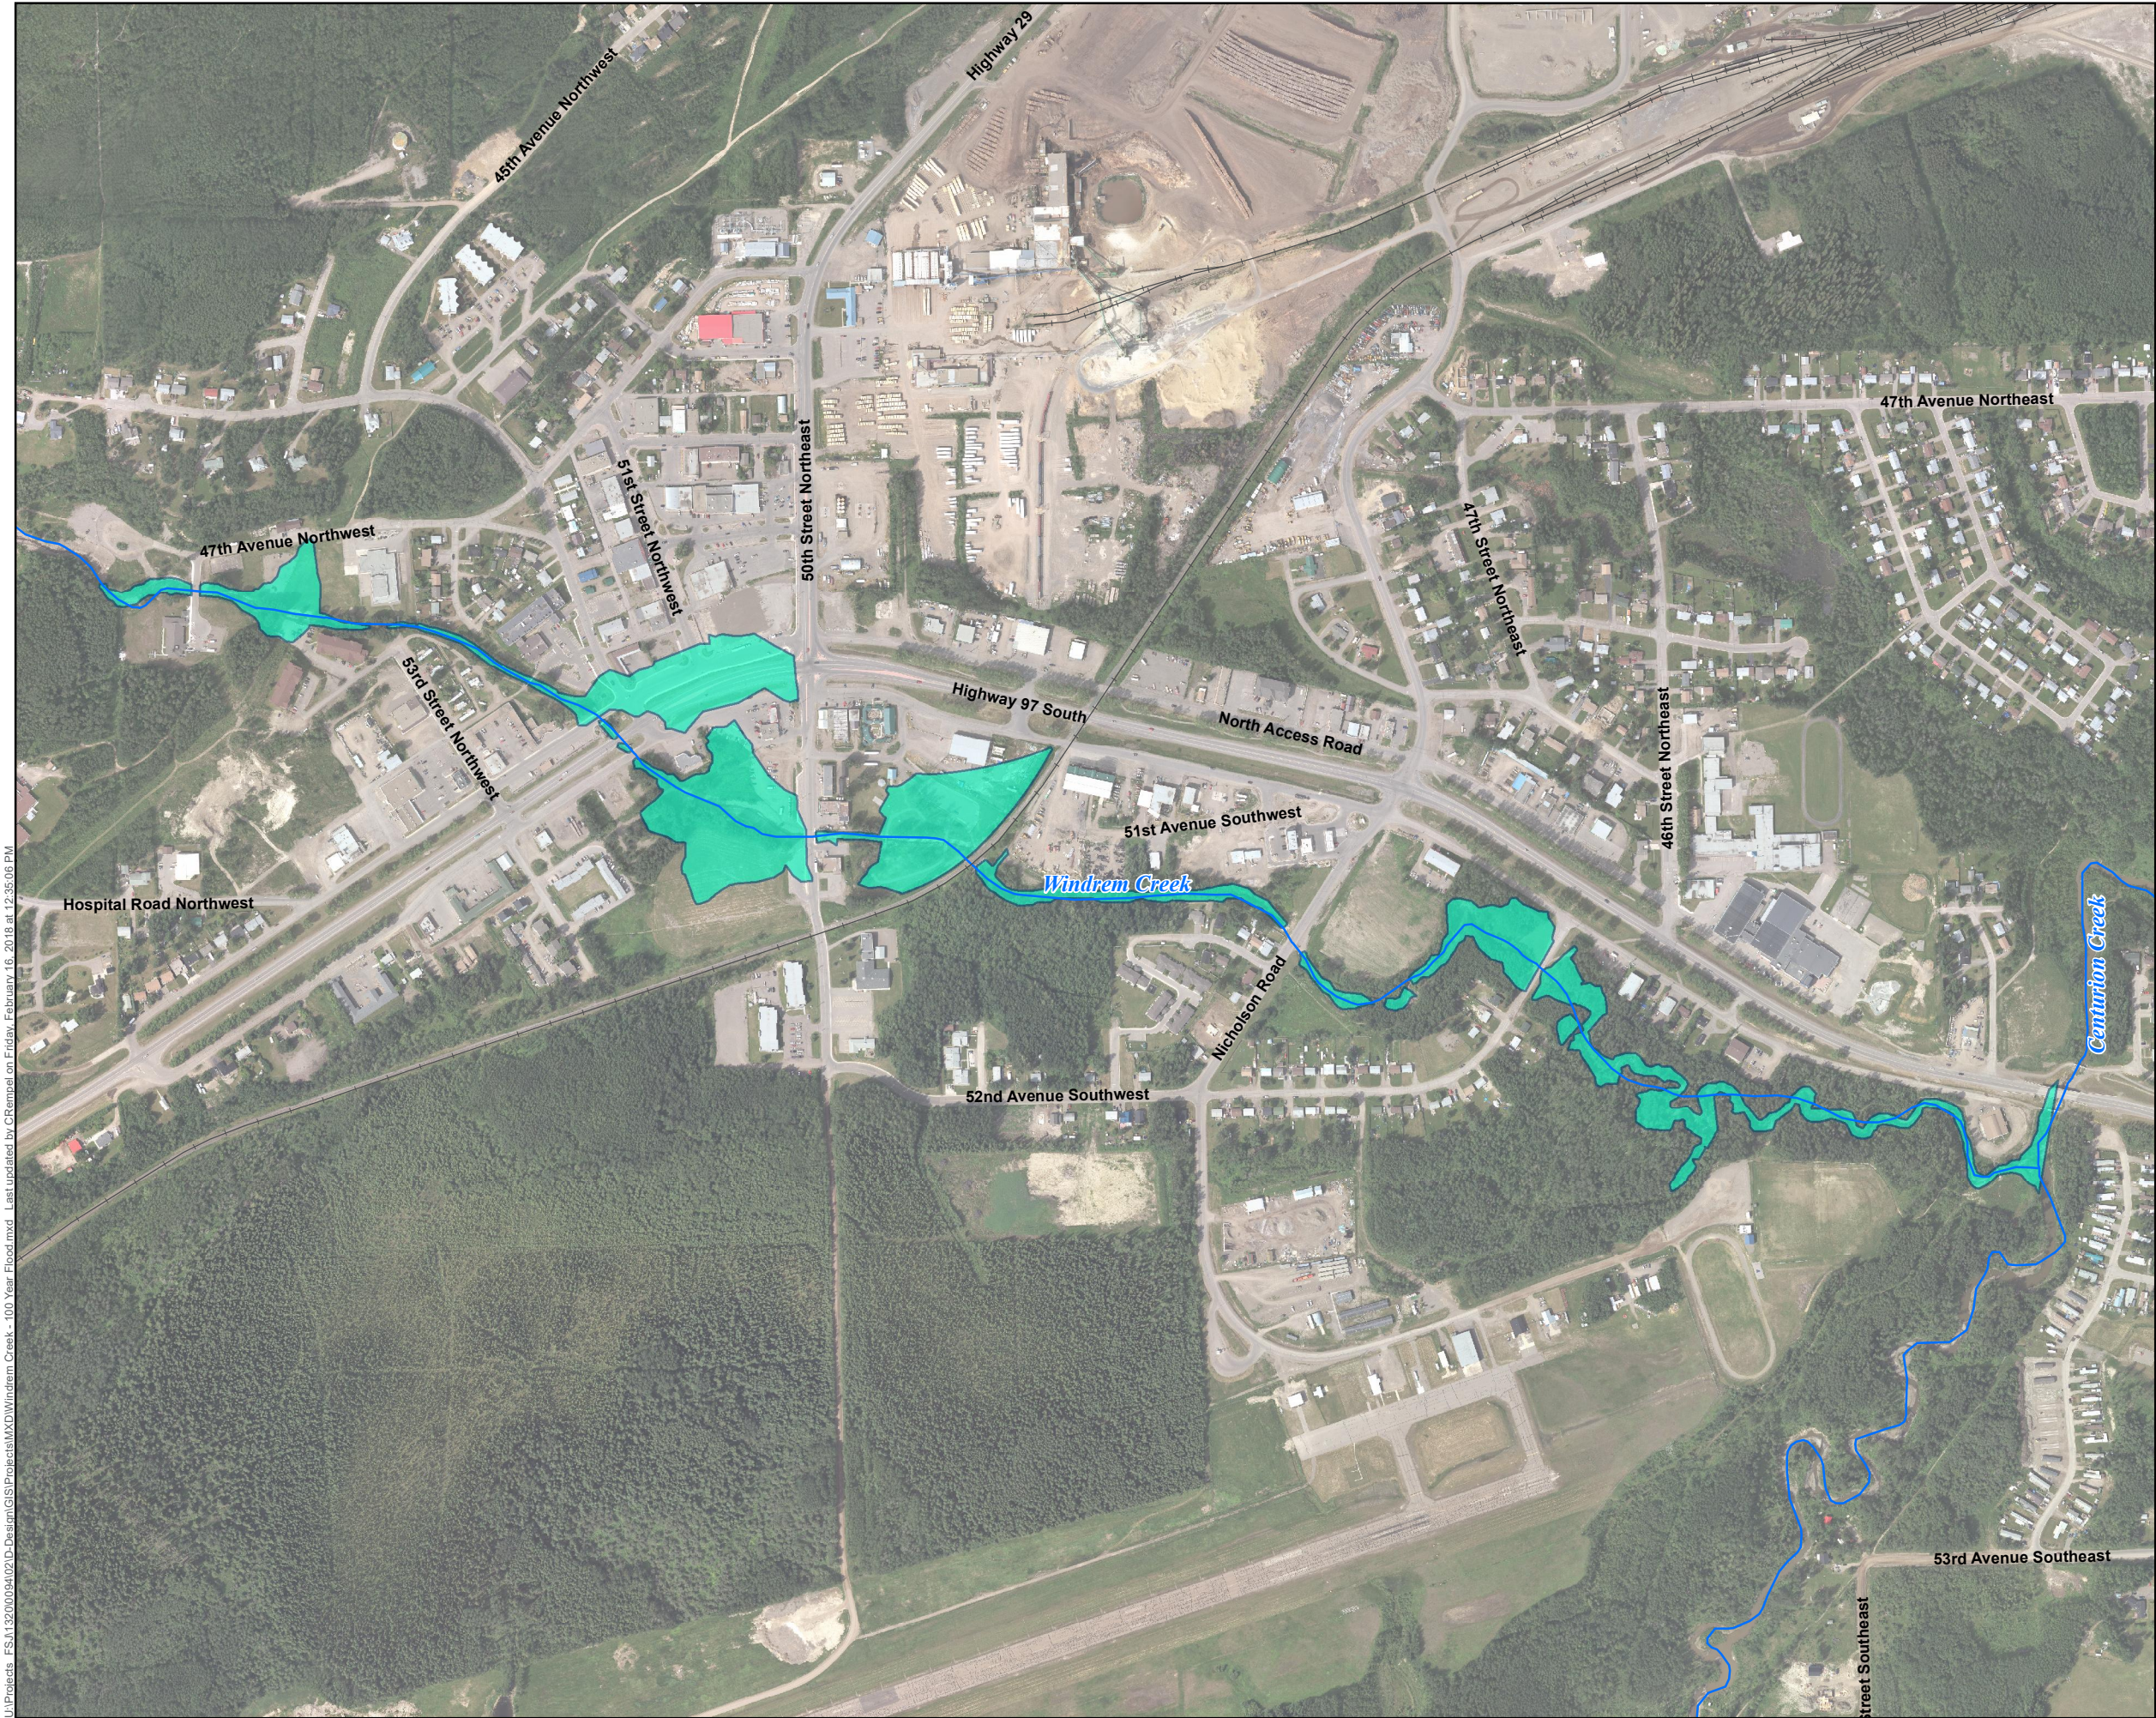
**FIGURE 16**

**Windrem Creek 100 Year  
Flood Hazard Area**
