# REPORT

## District of Chetwynd Flood Hazard Study

File: 1320.0094.02

November 26, 2018

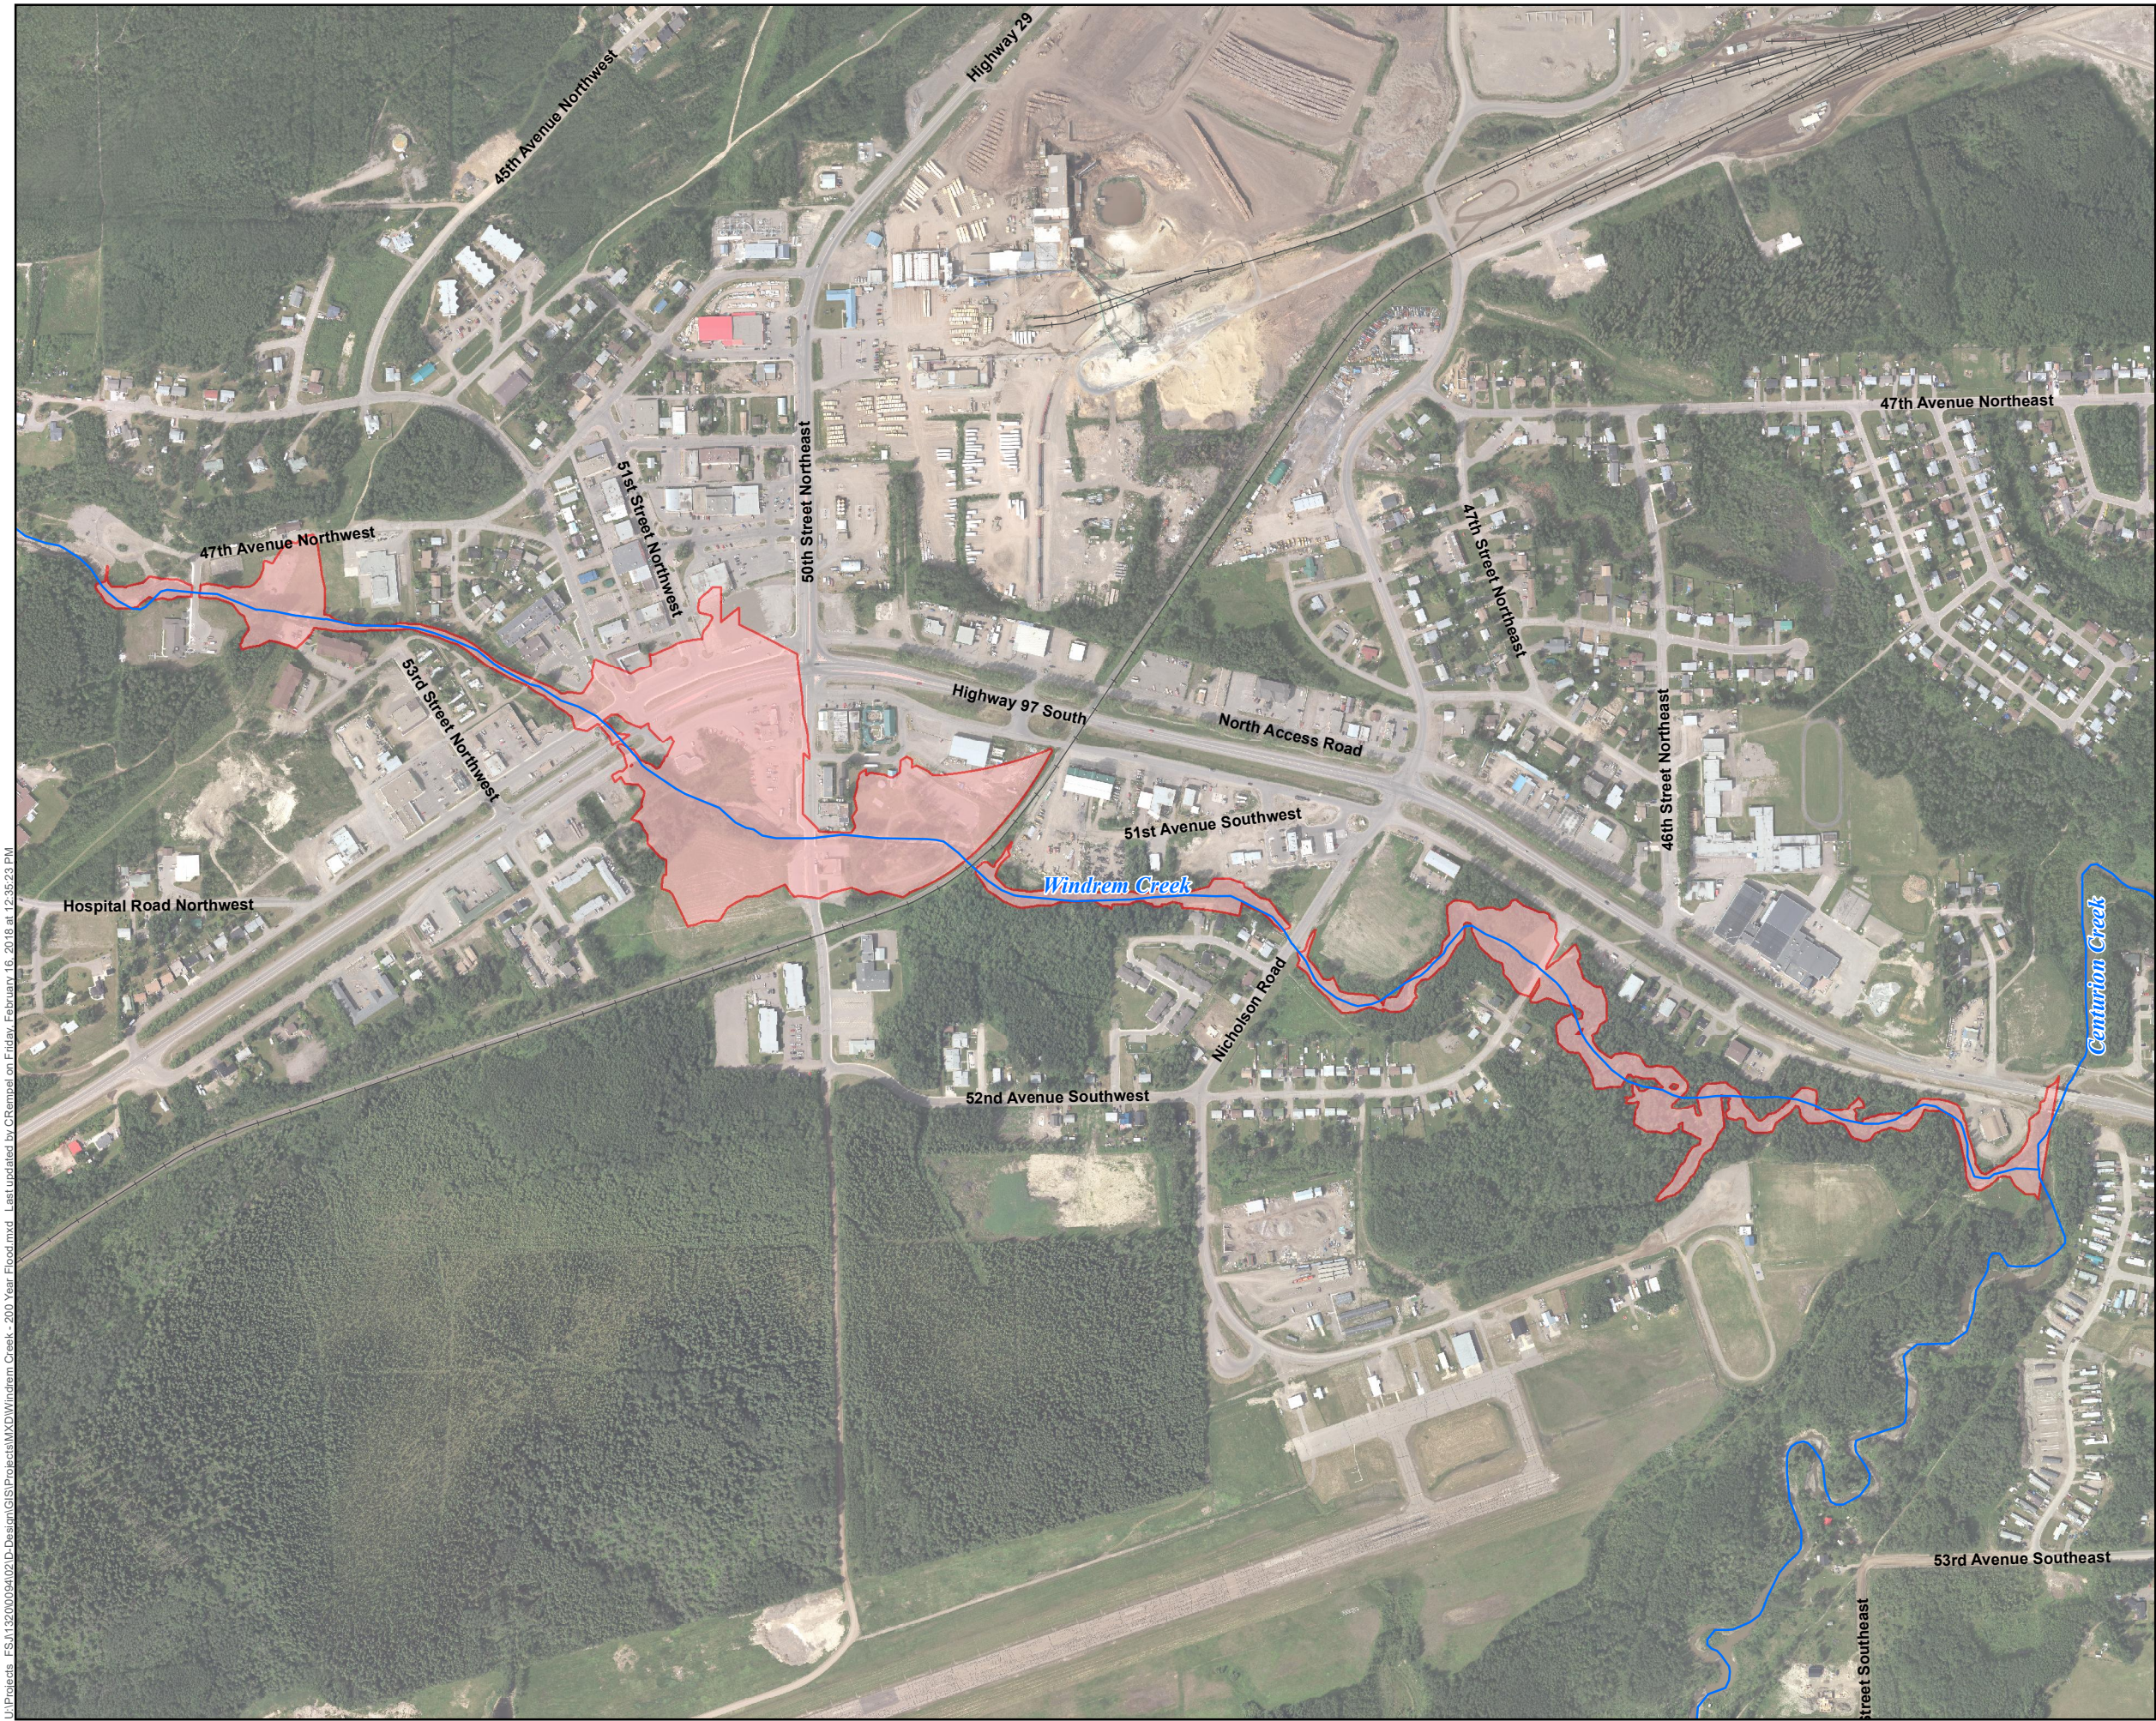
**FIGURE 17**

**Windrem Creek 200 Year  
Flood Hazard Area**

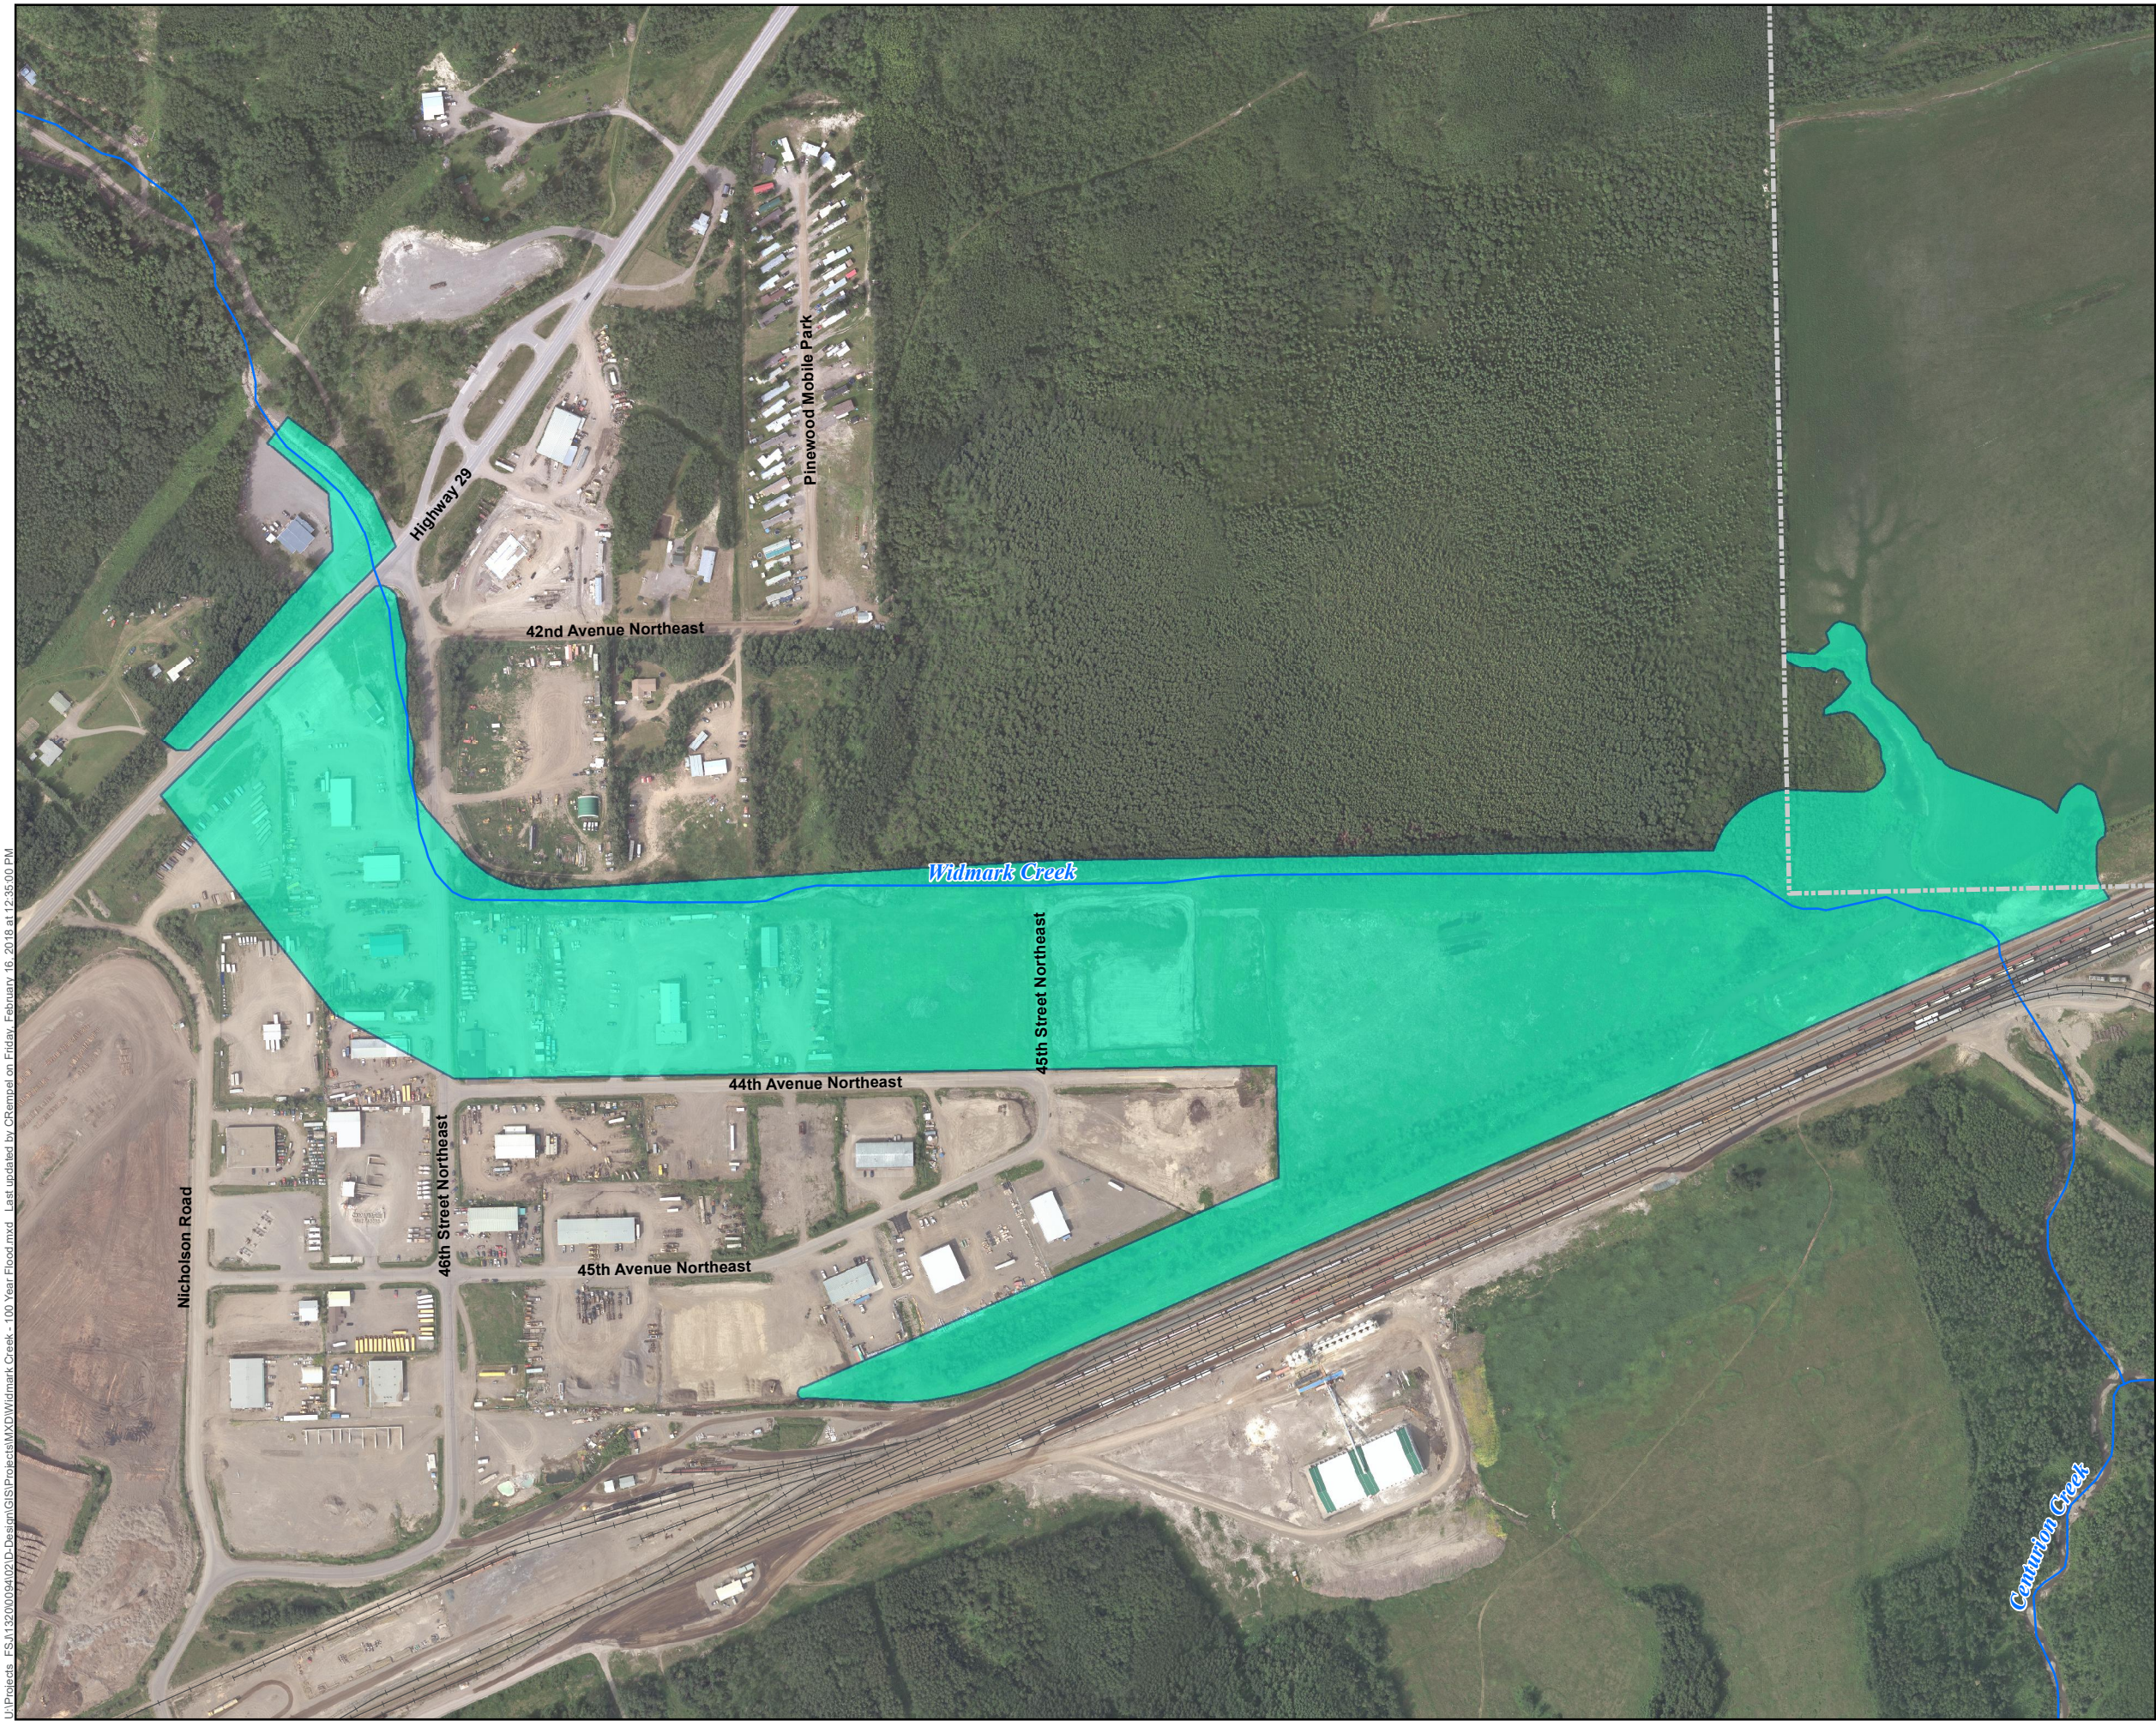
**FIGURE 18**

### Widmark Creek 100 Year Flood Hazard Area

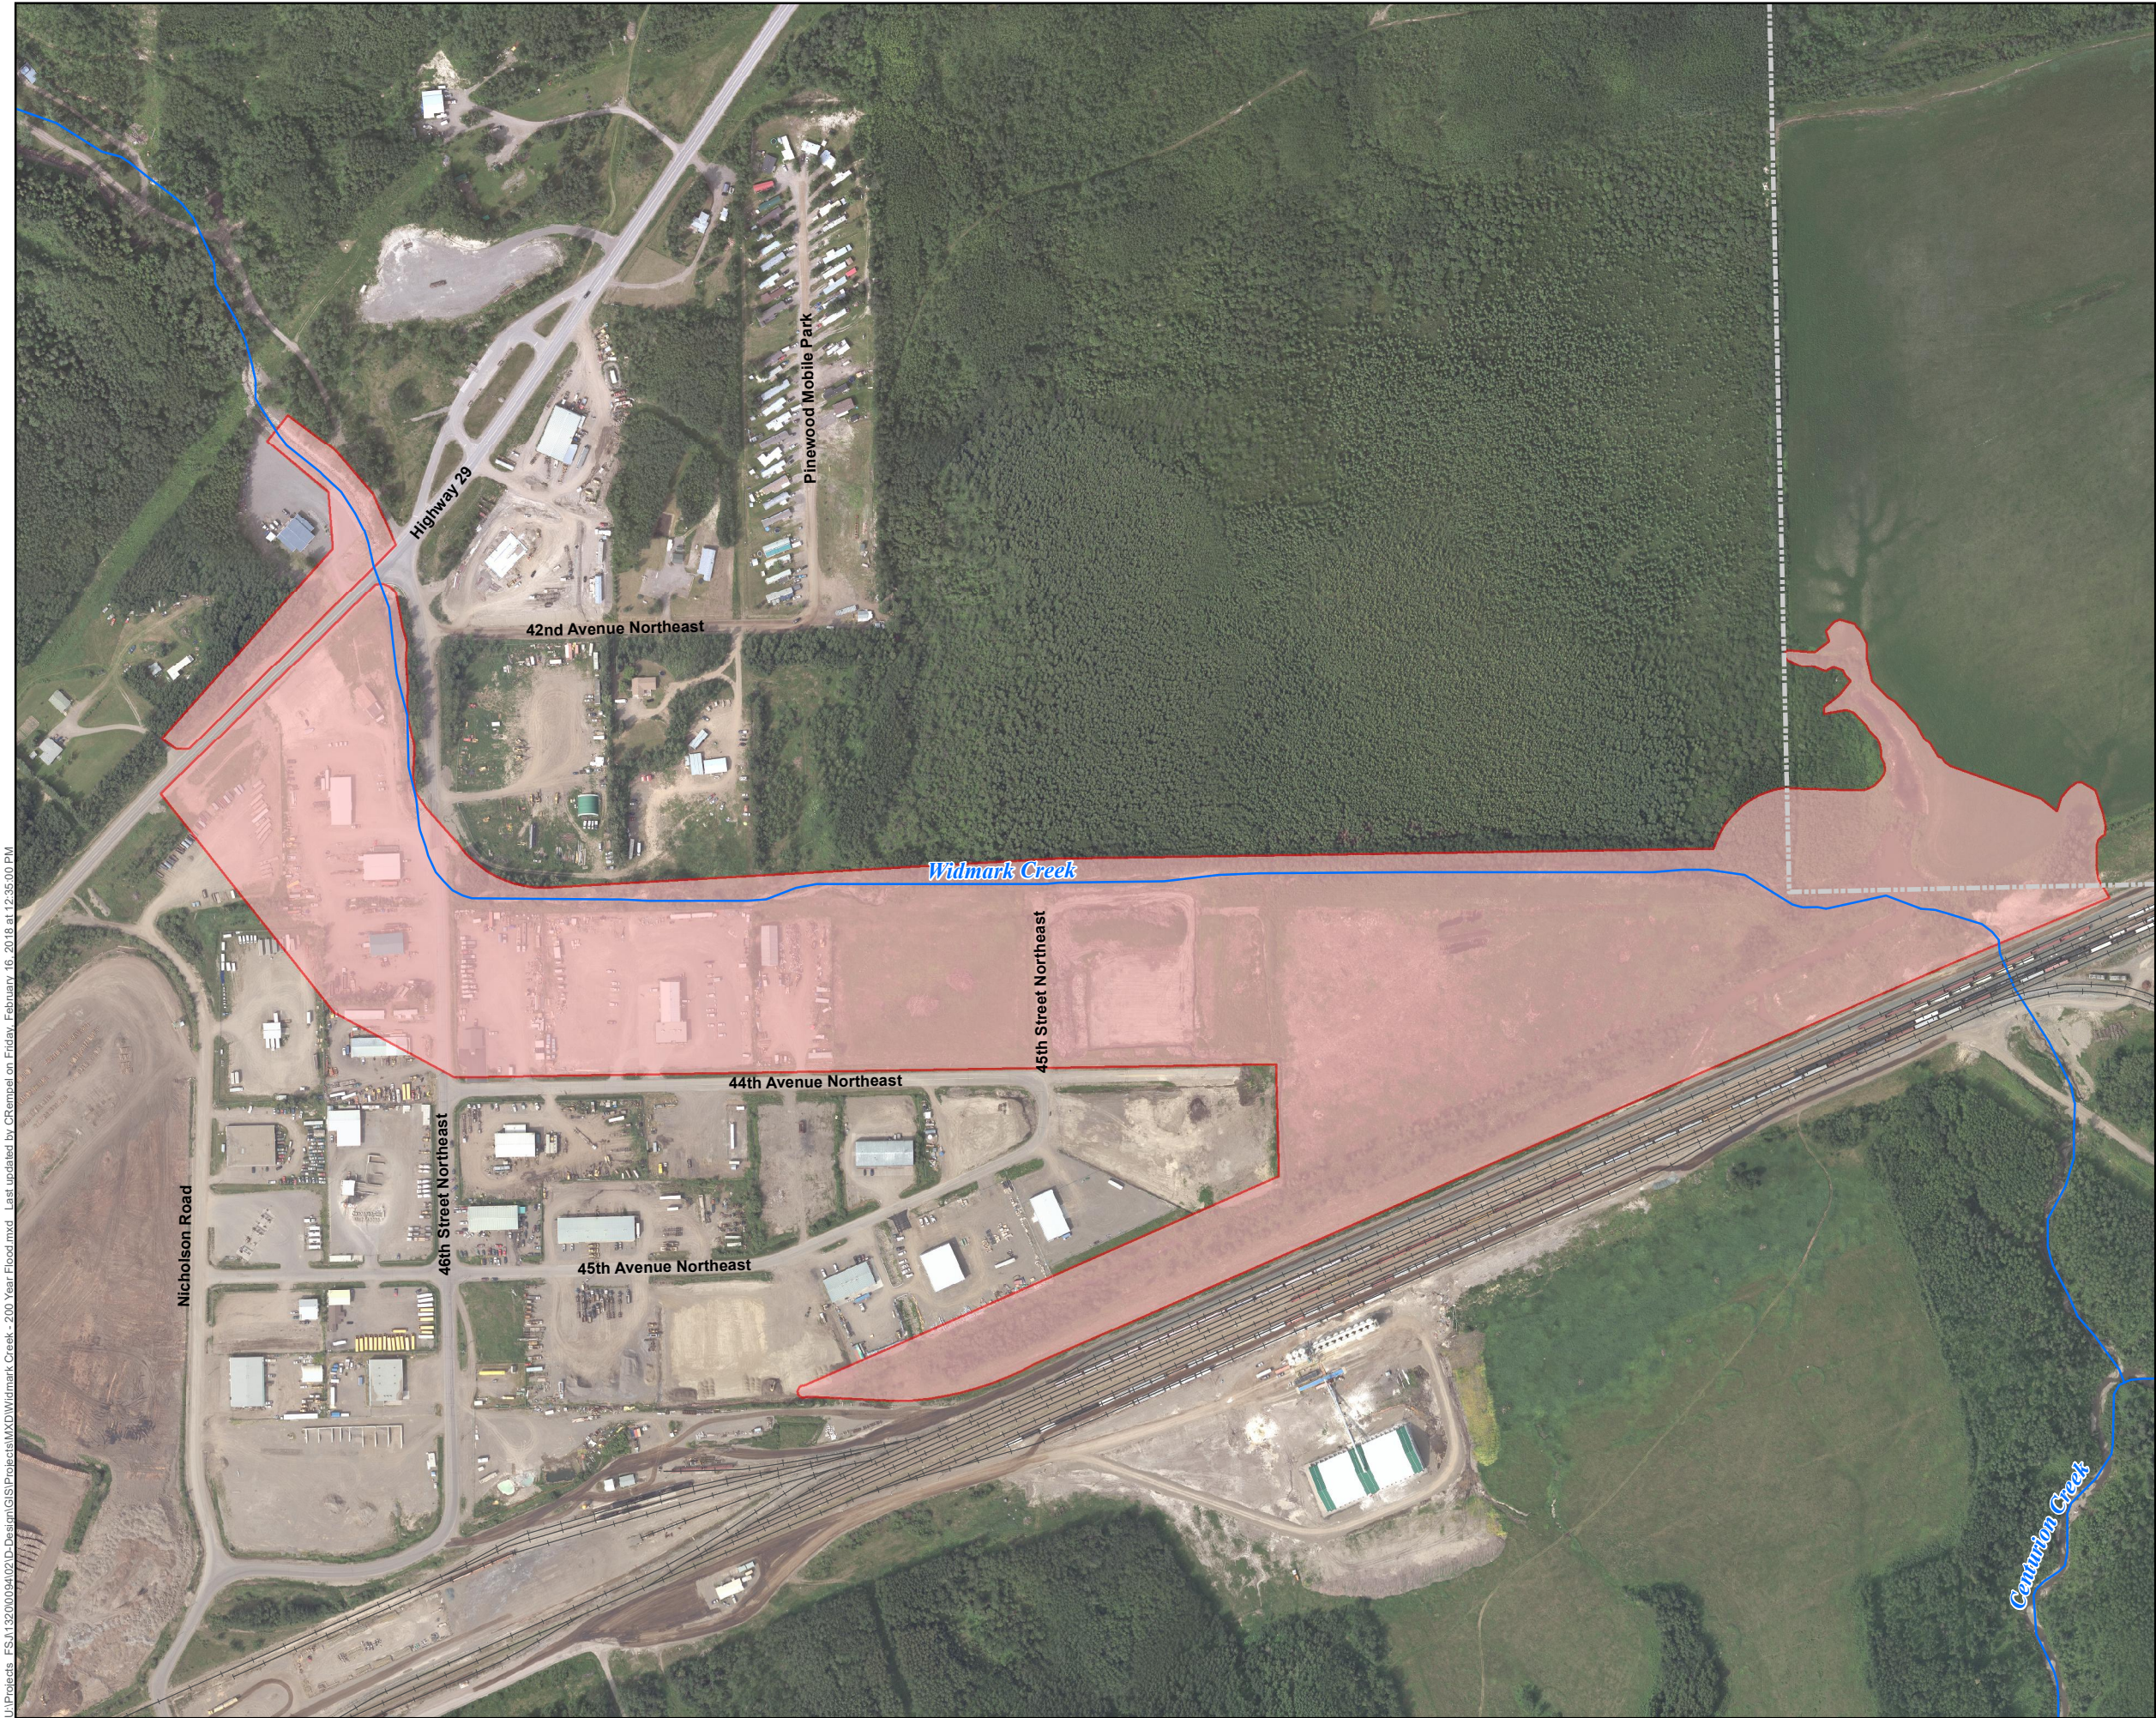
Widmark Creek 200 Year  
Flood Hazard Area

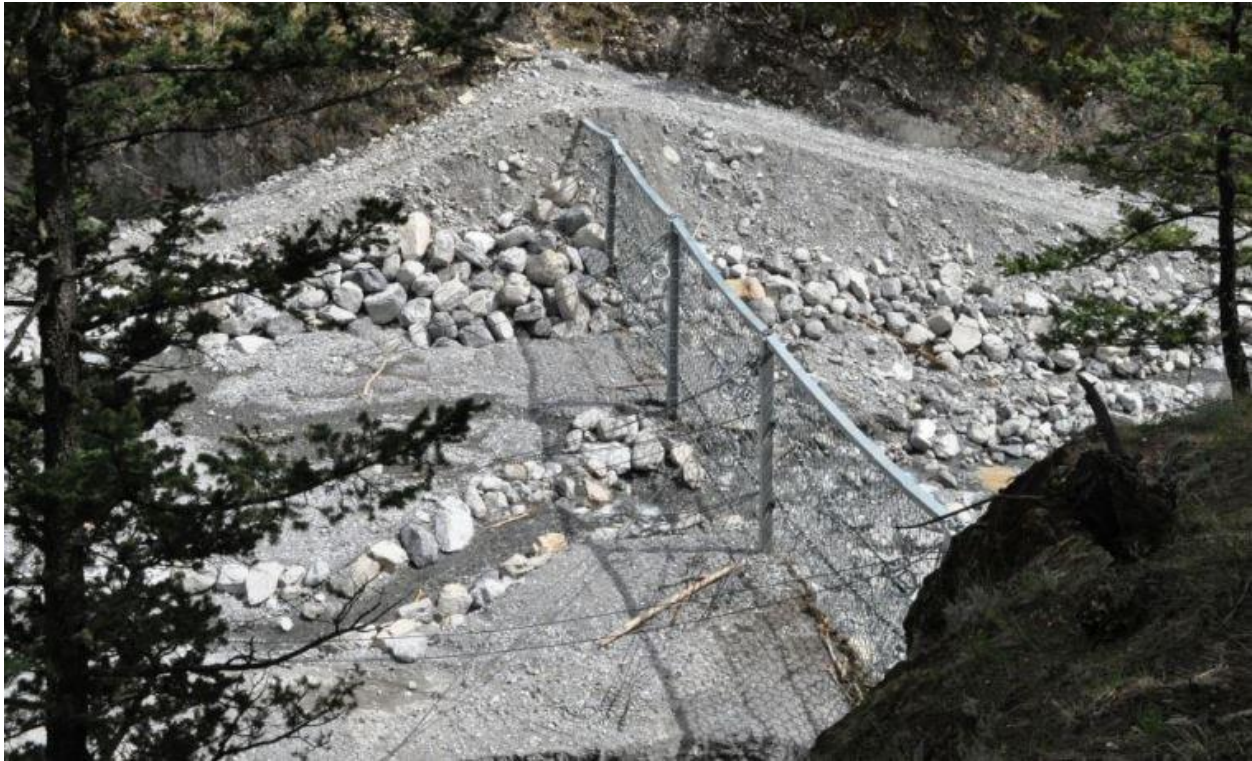
Figure 20 – Debris Net, Canmore Alberta (courtesy of Geobruigg)

In order to protect the community, a debris barrier could be located in each of the Windrem Creek and Widmark Creek channels near the location where the channels make the transition from gulley to fan. Possible locations are shown on Figure 21 for Windrem Creek, and Figure 22 for Widmark Creek.

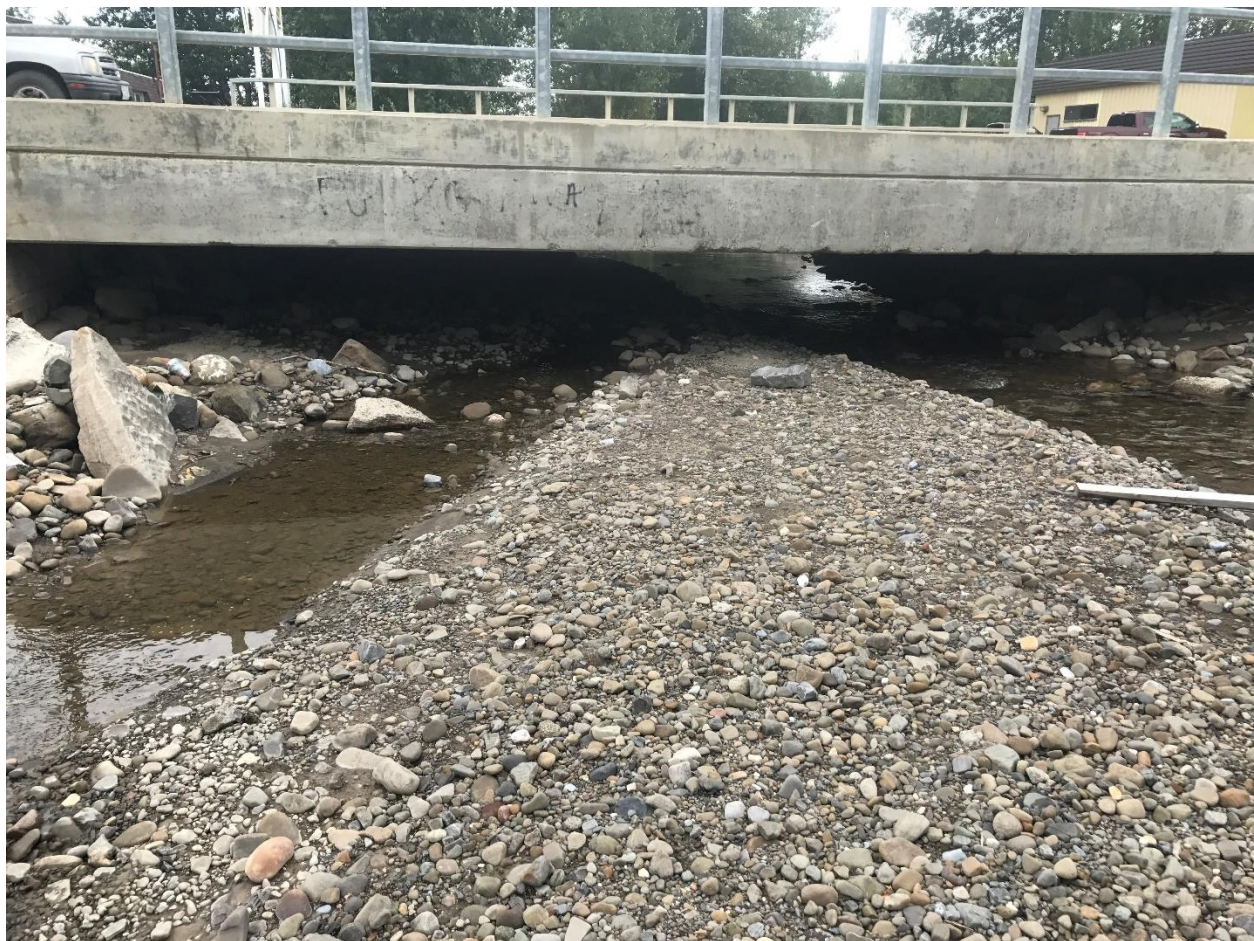
**Figure 23 – Gravel Accumulation Under 50<sup>th</sup> Street Bridge**

There is one location on Windrem Creek where immediate action should be taken, and this is immediately upstream of the 50<sup>th</sup> Street bridge. This location is particularly prone to gravel accumulation because the channel slope becomes flatter at this location, and the channel also becomes wider, which reduces the shear stress on the creek gravels. There is evidence that the hydraulic capacity of the bridge has been compromised over time through the accumulation of gravel under the bridge itself as shown on Figure 23.

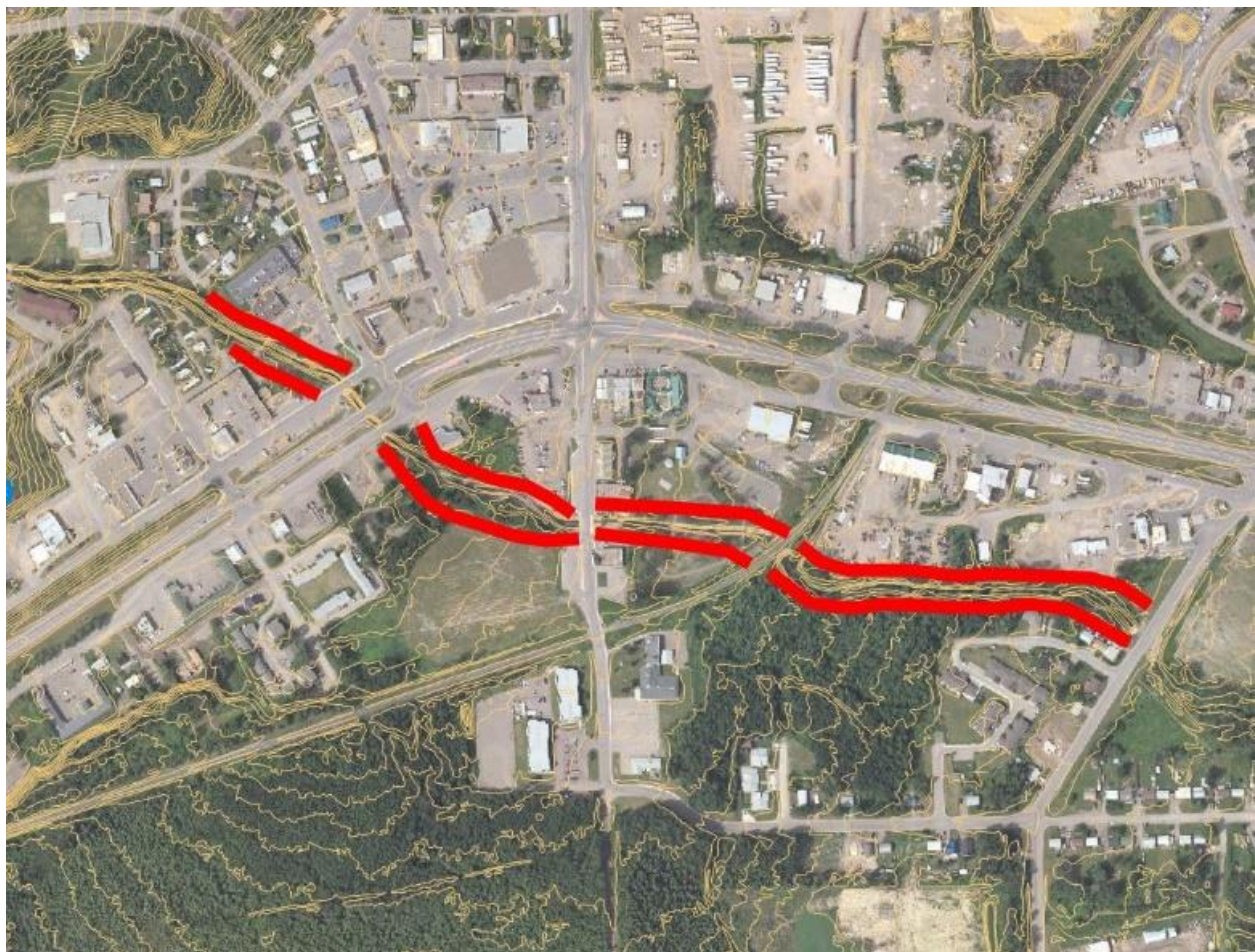
**Figure 24 – Windrem Creek Flood Protection Berms**

For Windrem Creek, that areas that would benefit from the construction of flood protection berms in order to contain the extreme event flows are located in the core of the community. Flood protection berms would contain the flows in the main channel in these areas where water surface elevations are impacted by the road crossings at the John Hart Highway, North and South Access Roads, 50<sup>th</sup> Street, and Nicholson Road, as well as the CN Railway crossing. Those estimated extent of the flood protection berms are shown in Figure 24.

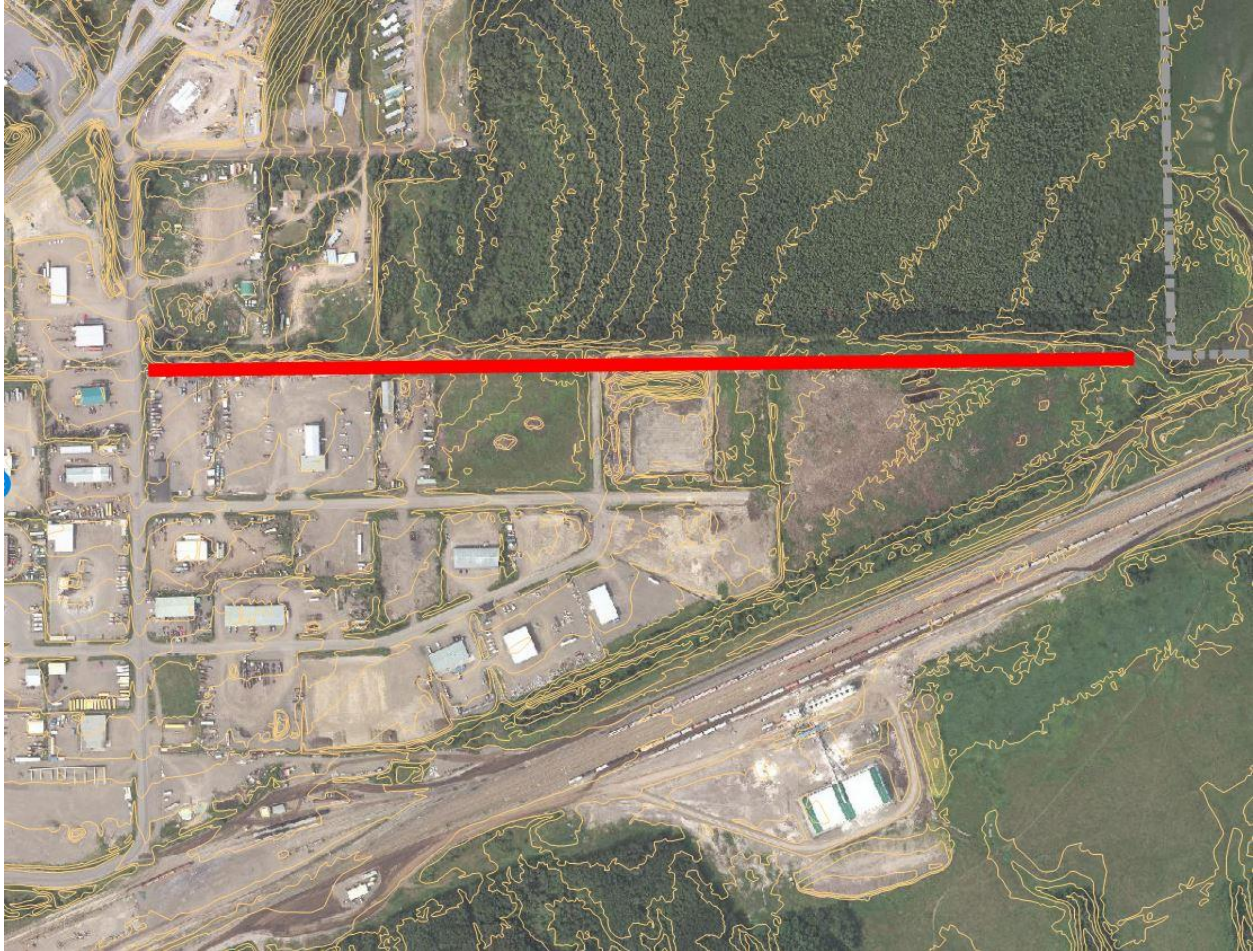
**Figure 25 – Widmark Creek Flood Protection Berms**

With respect to Widmark Creek, the area of concern is the future development area on the north side of 44<sup>th</sup> Avenue NE. The estimated extent of the flood protection berm for this area is shown on Figure 25.
