# REPORT

## District of Chetwynd Flood Hazard Study

File: 1320.0094.02

November 26, 2018

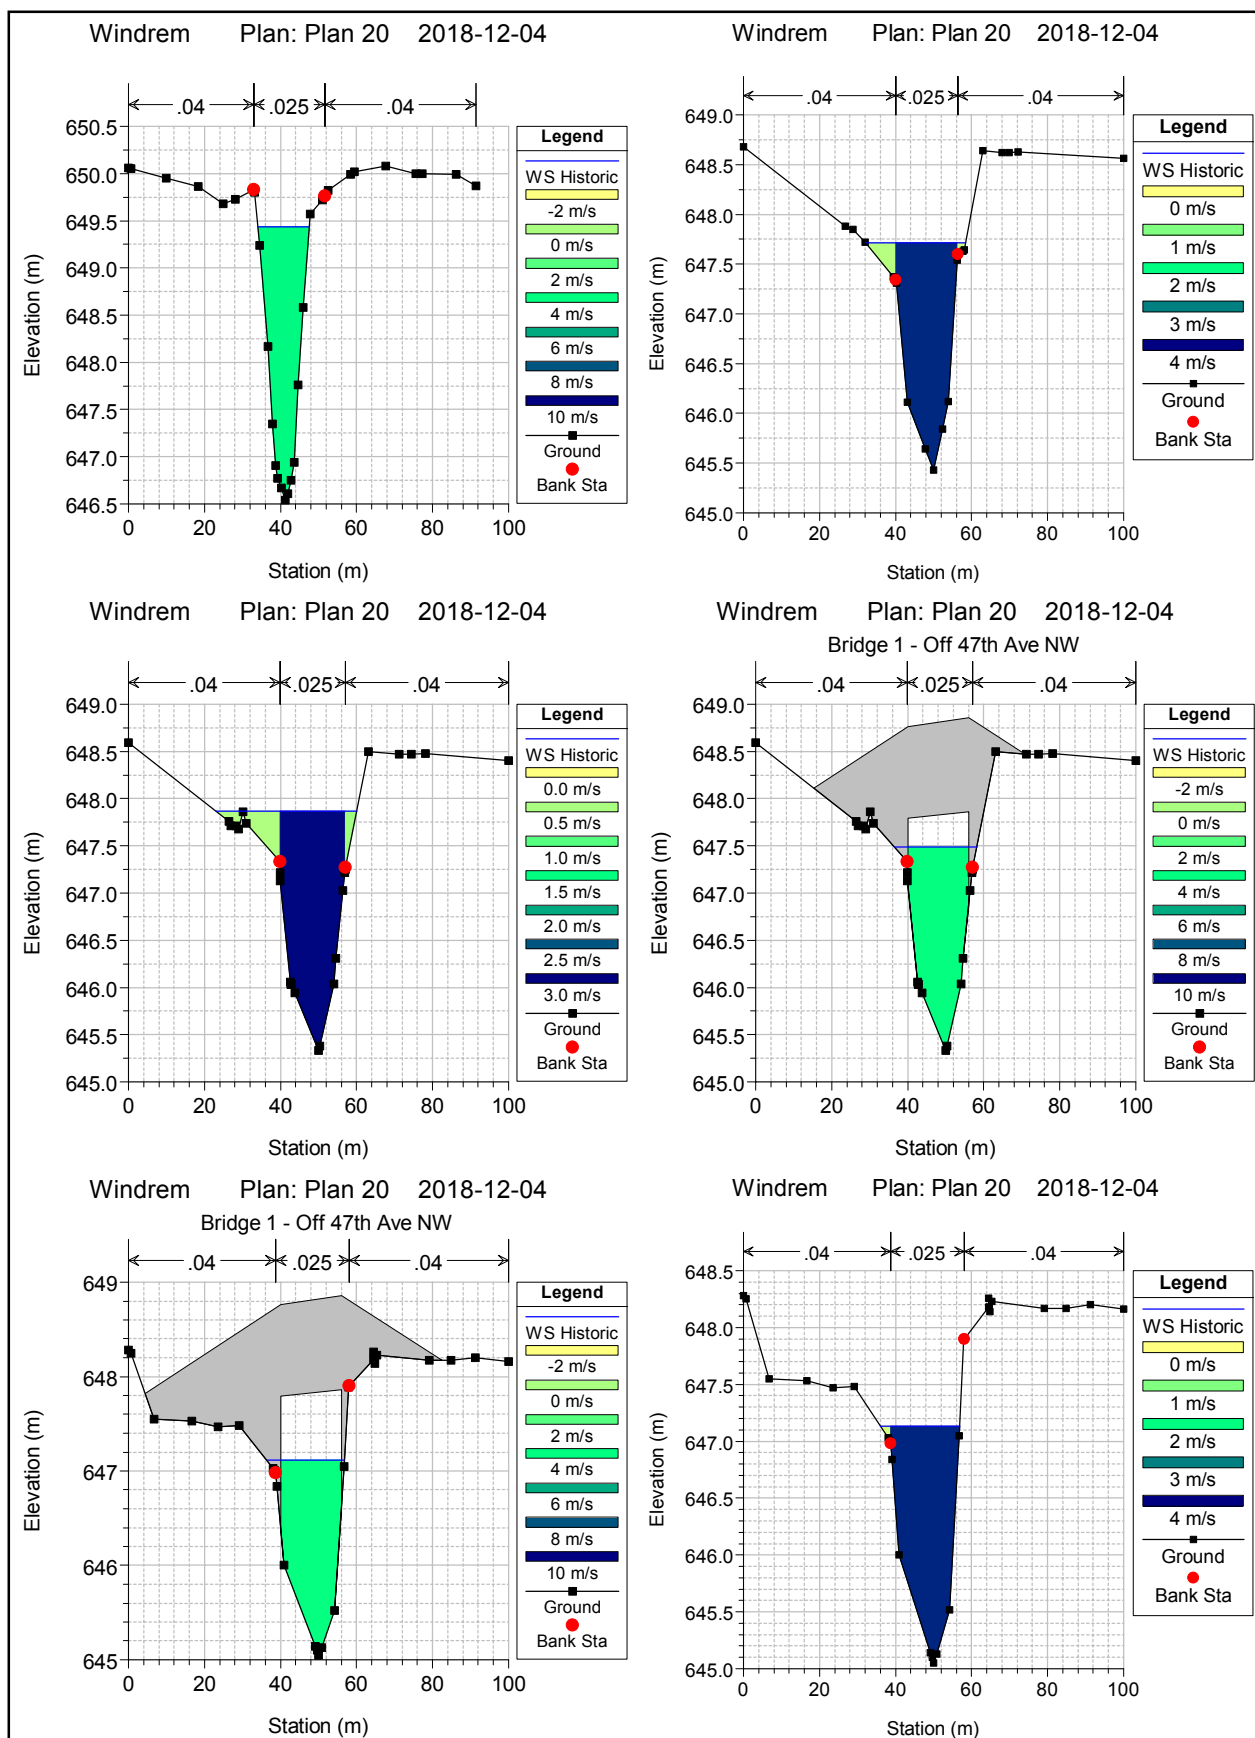
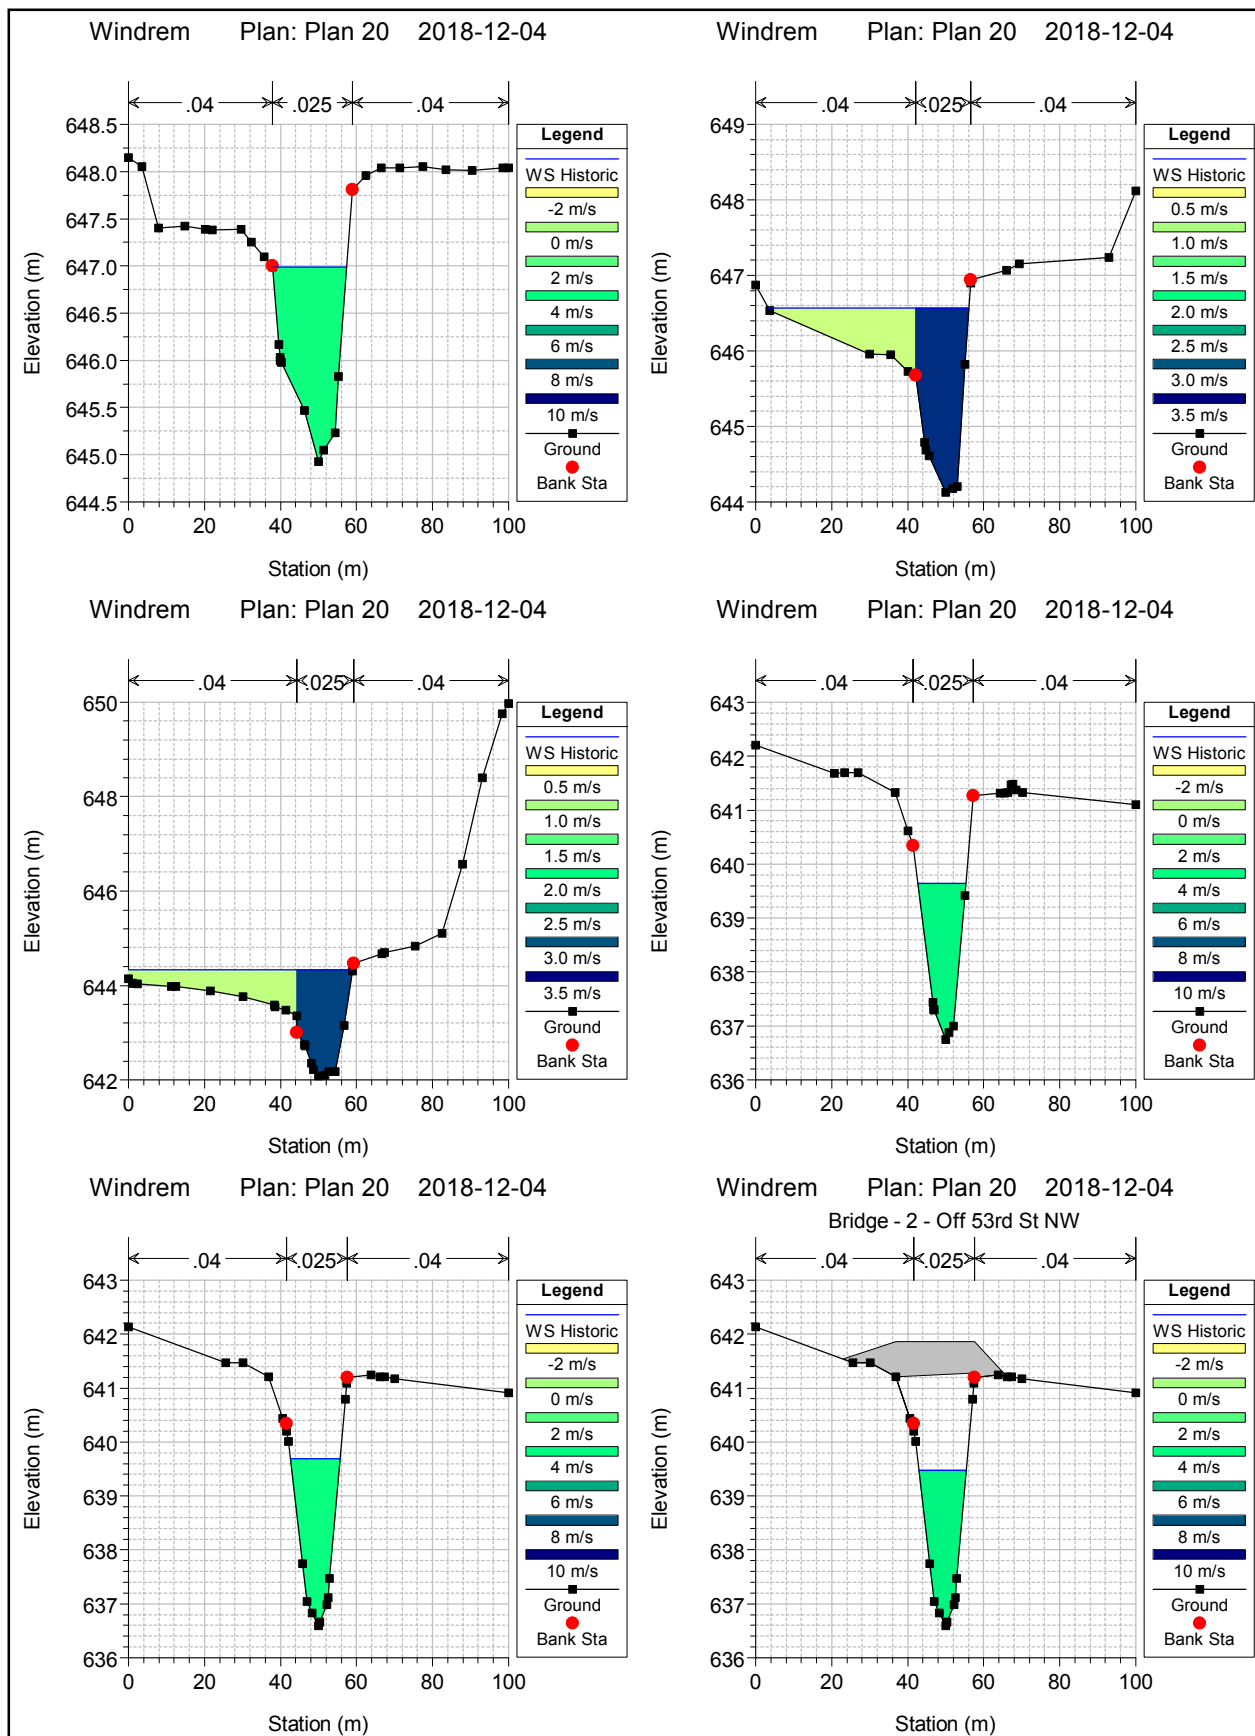
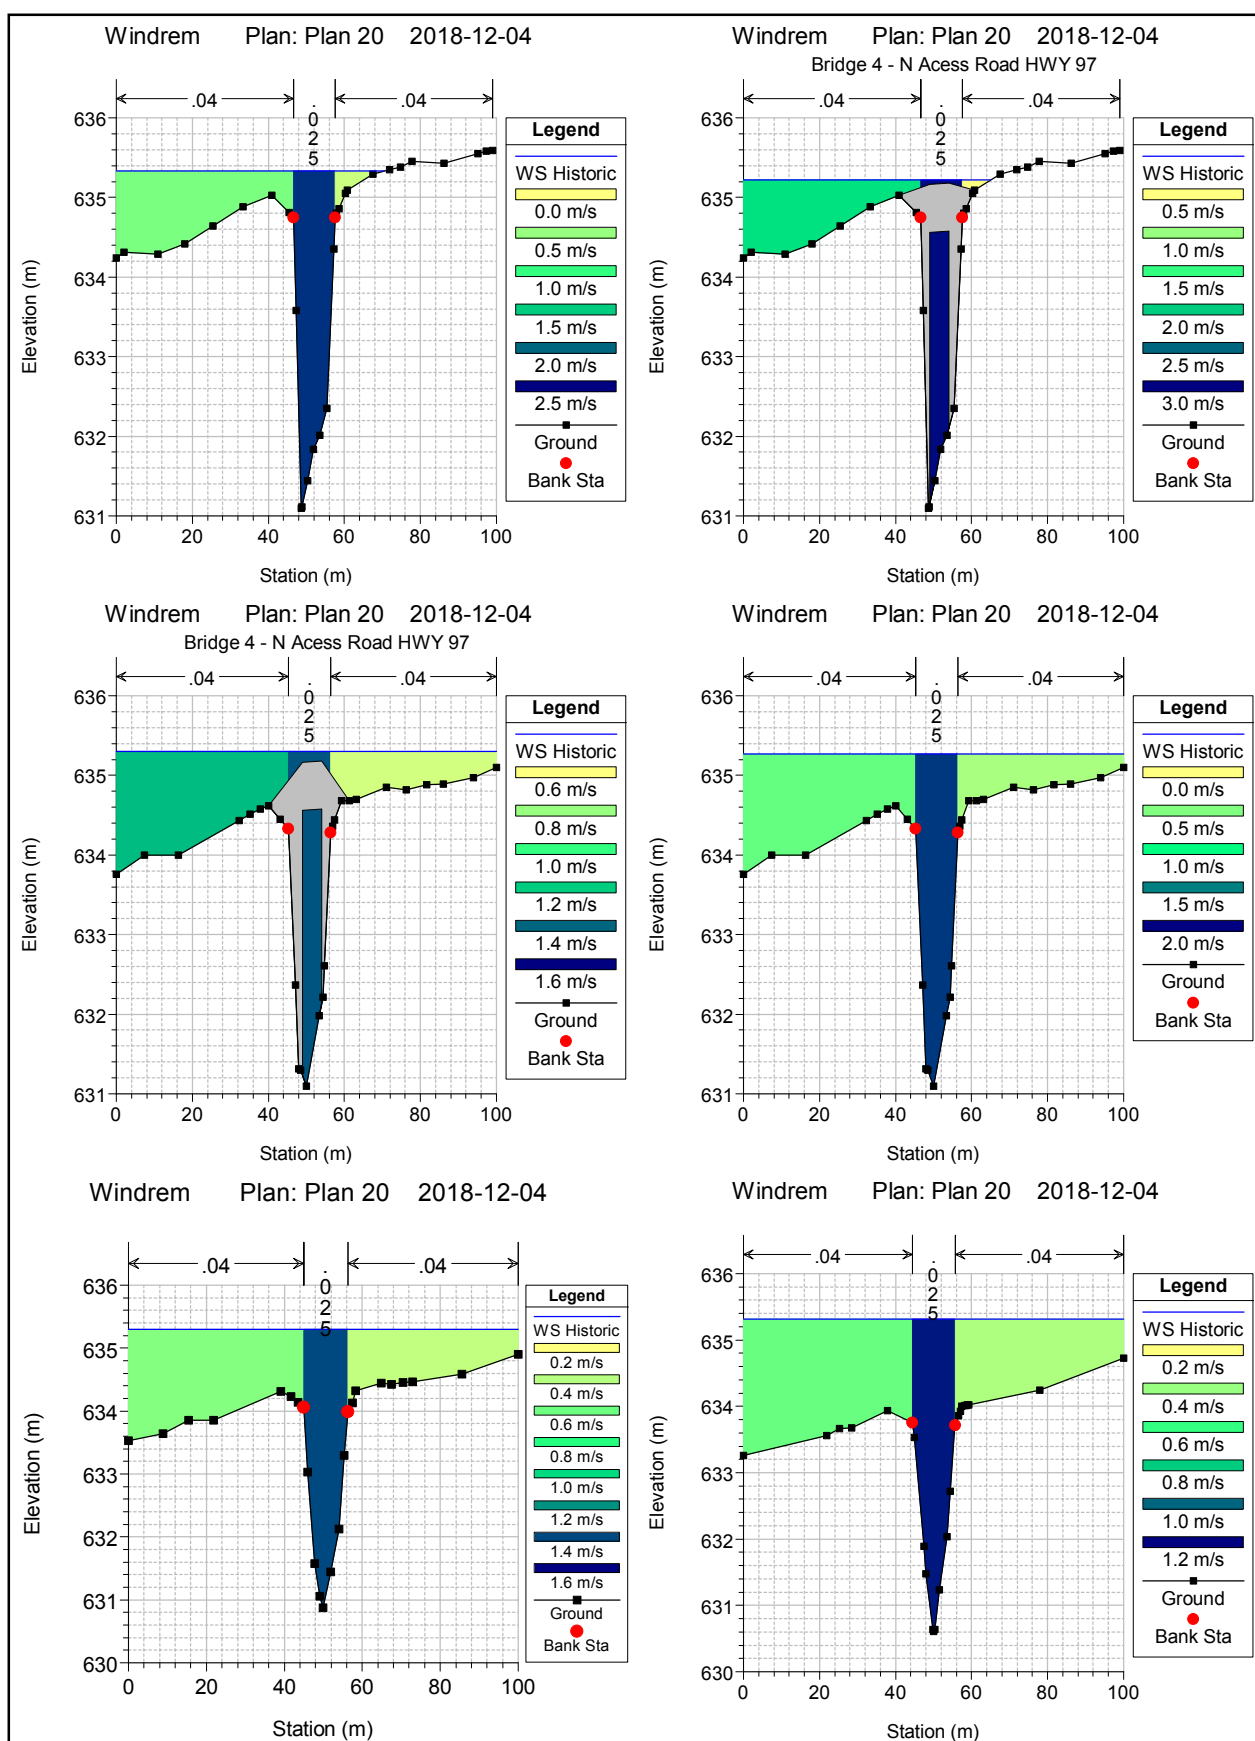
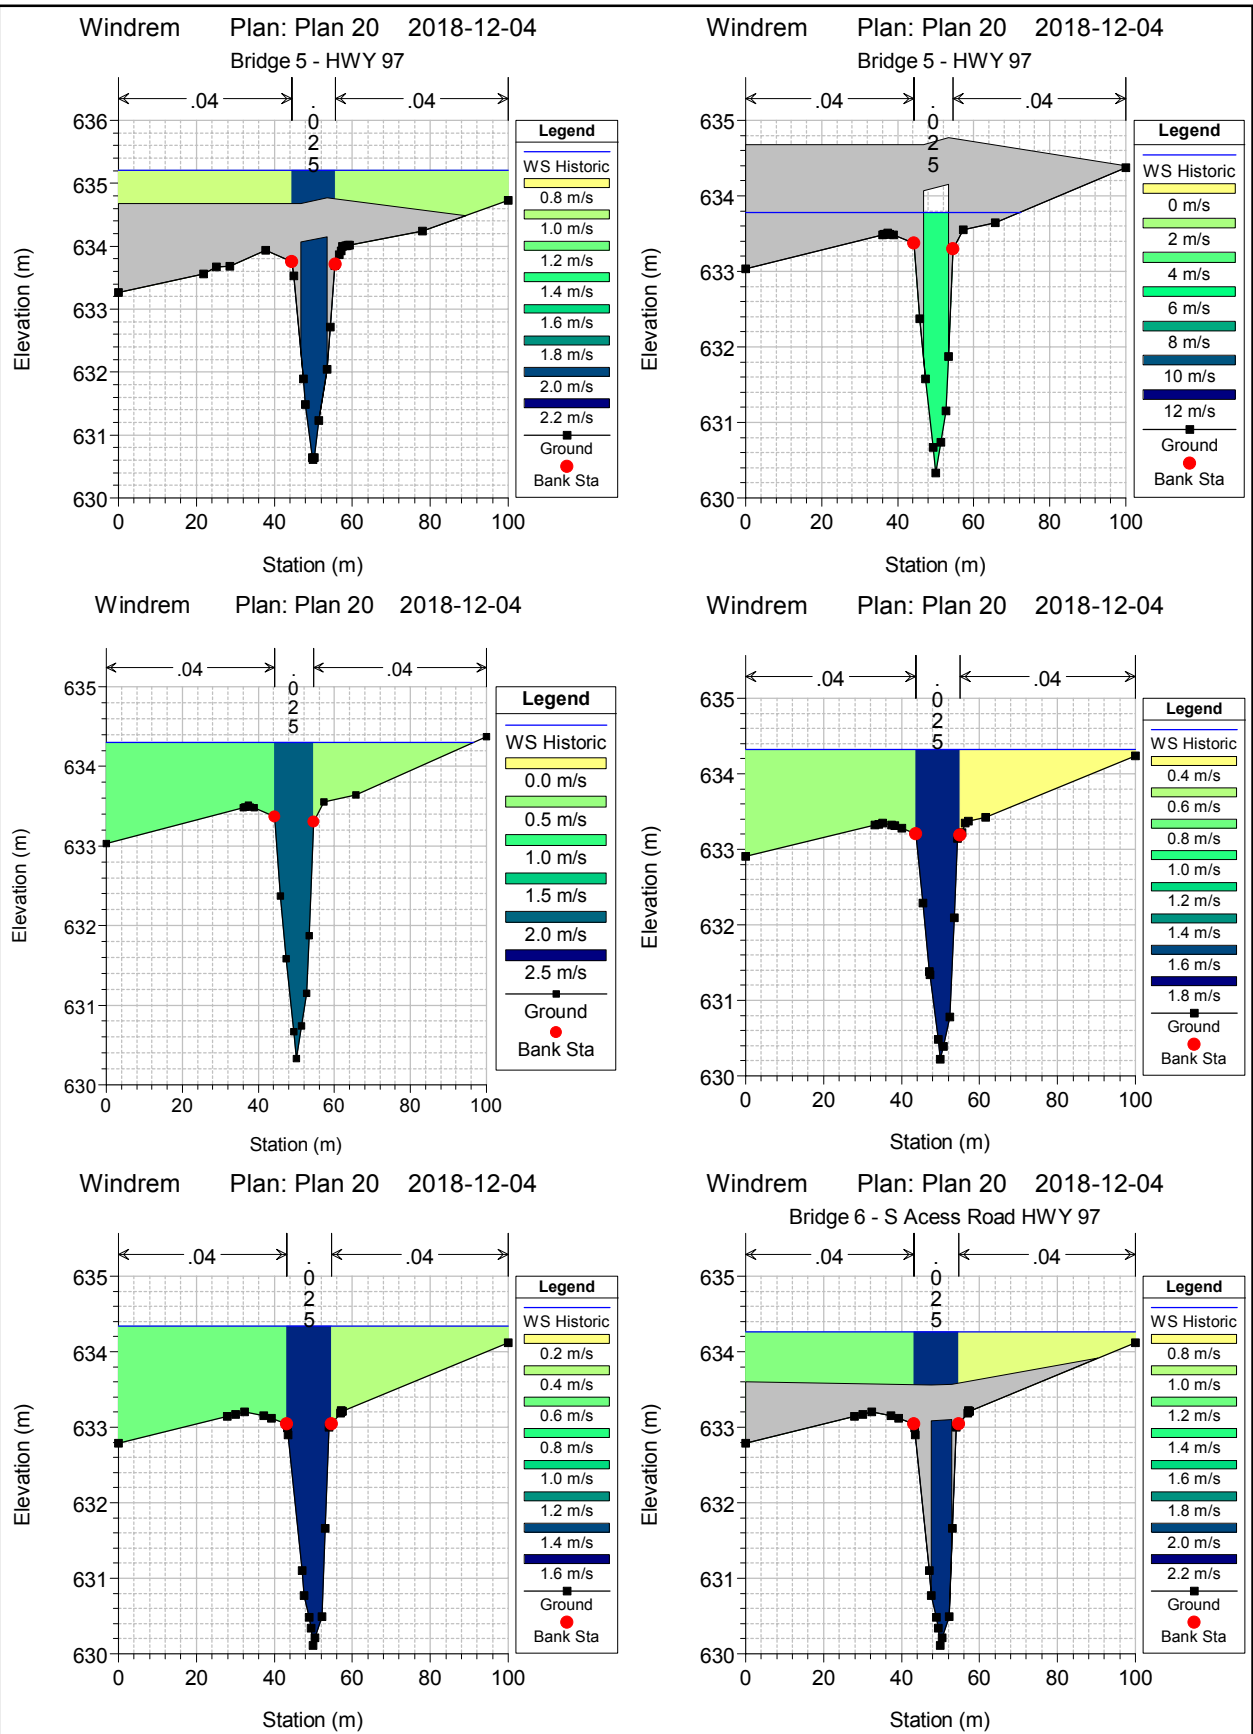
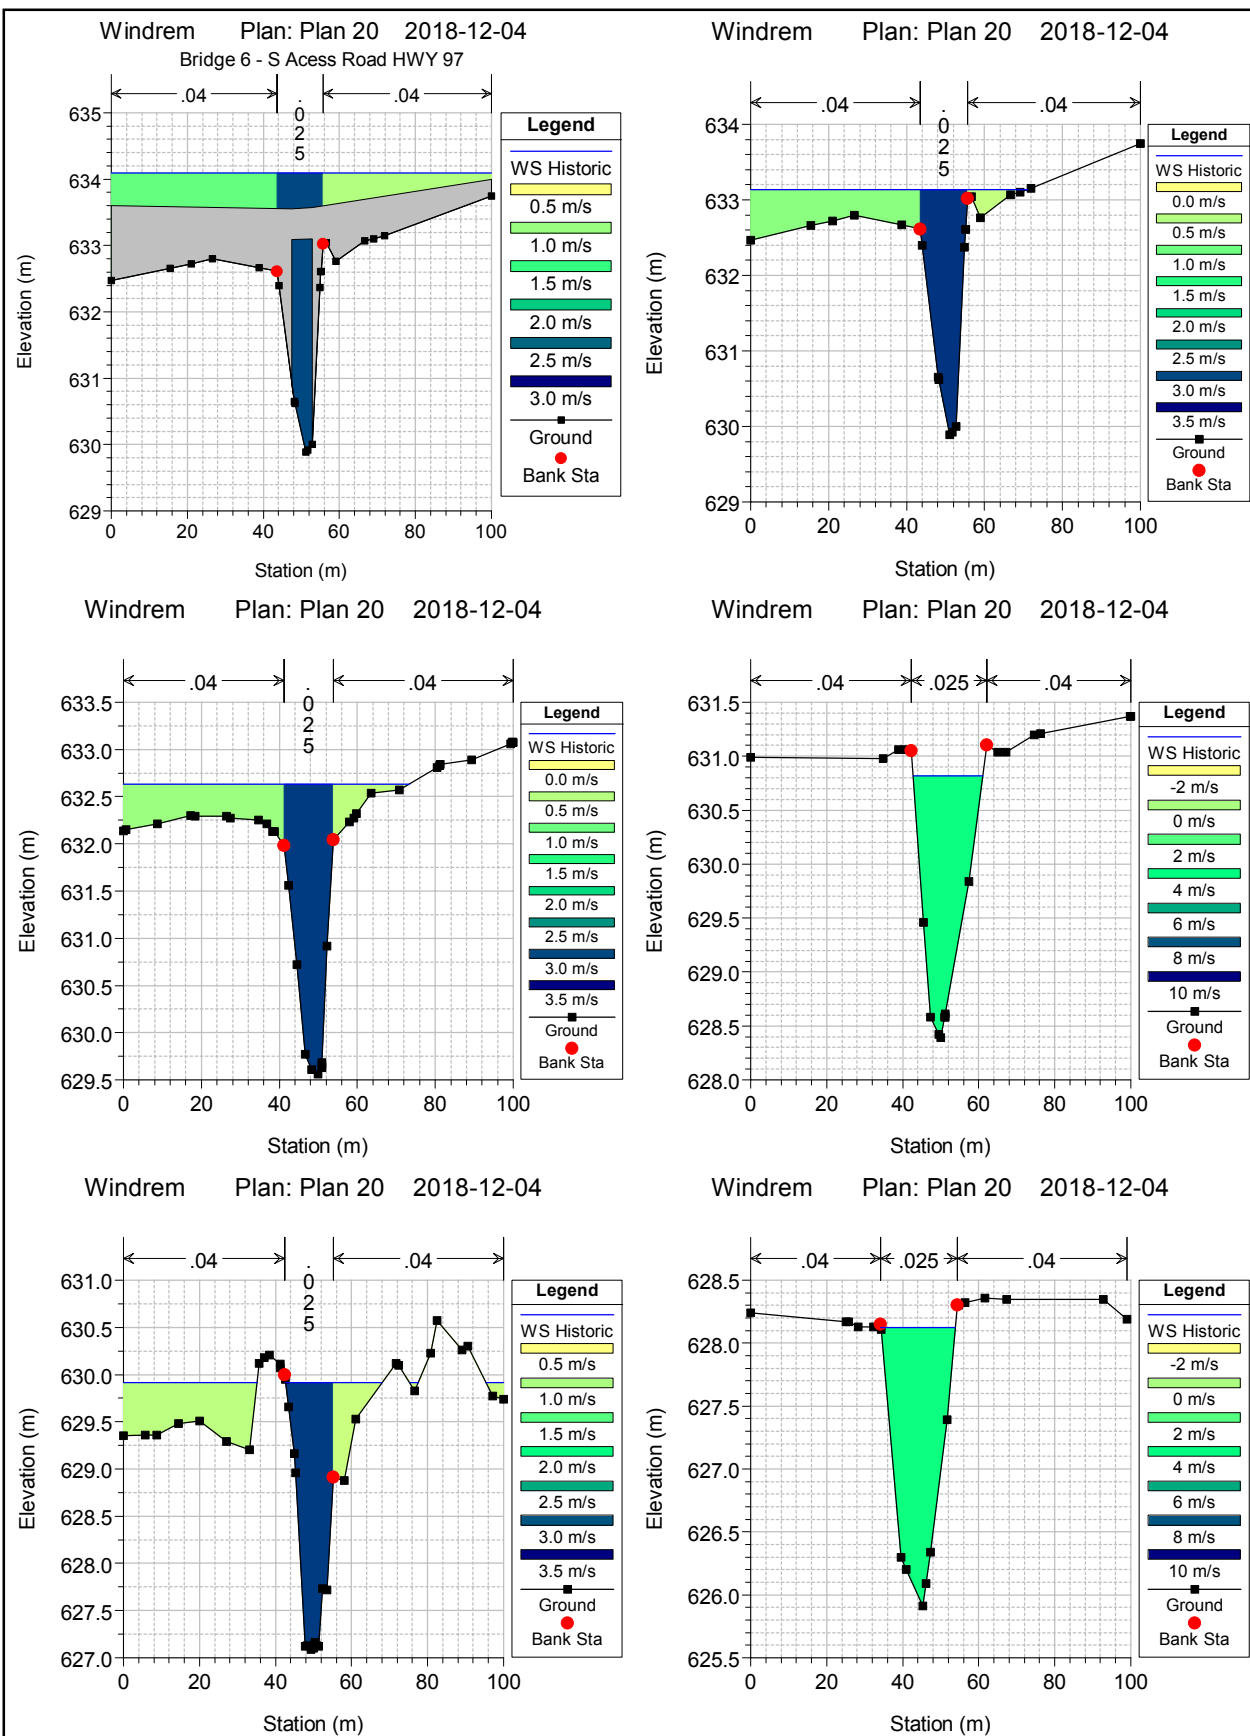
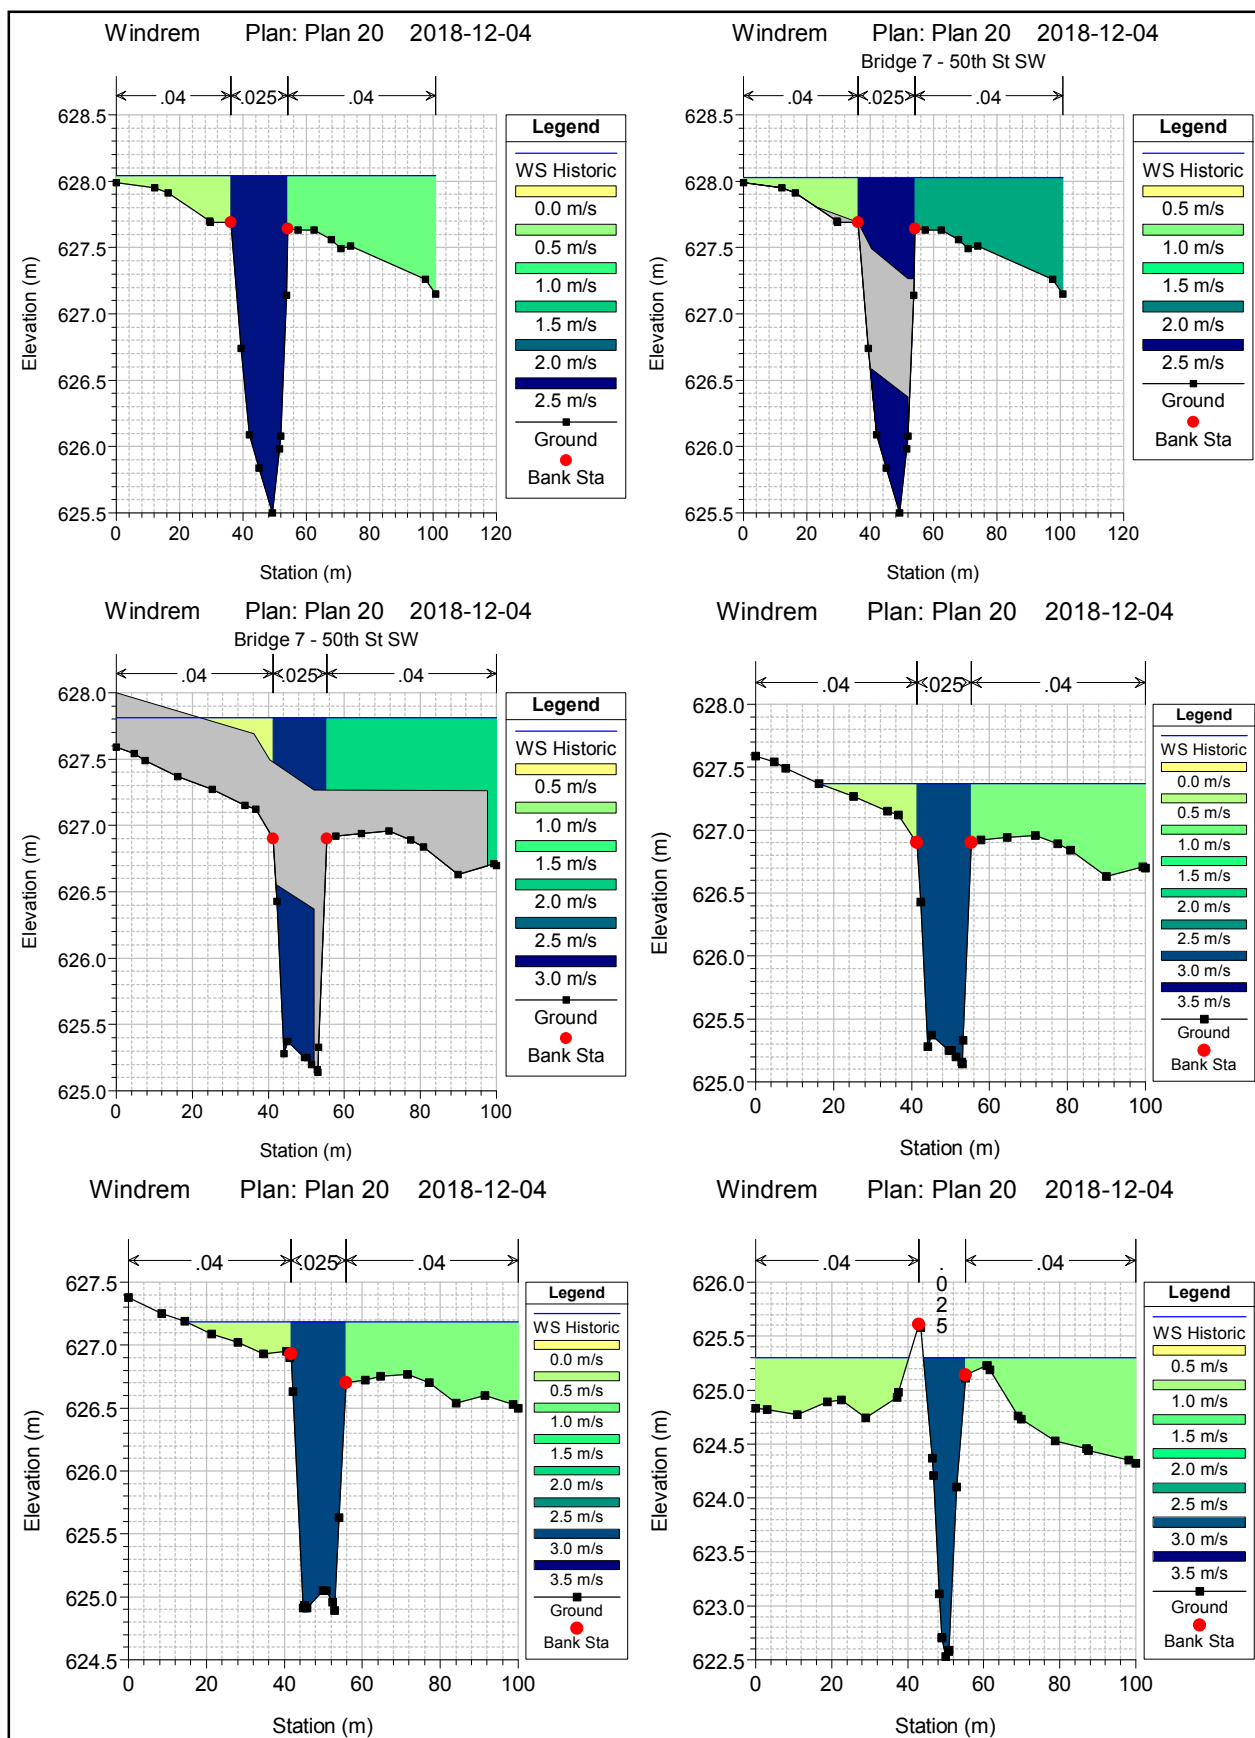
## *HEC RAS Model Results*

HEC-RAS models were created for each of the Windrem Creek and Widmark Creek channels for the historic condition, median future climate change condition, and 90th percentile future climate change condition for both the 100 year and 200 year return period events. The key outputs of the models are calculated water surface elevations at each modelled cross section, along with flow velocities and channel shear stresses. The water surface elevations are used to identify areas where overbank flooding is likely to occur during the various design events, while flow velocities and shear stresses show segments of channel that are susceptible to erosion. These areas are shown graphically in Appendix A.
